Failure analysis of a fractures orthopedic implant

Failure analysis of a fractured orthopedic implant

Institute for Technological Research of the State of São Paulo (IPT)

Tenth International Conference on Engineering Failure Analysis – ICEFA X

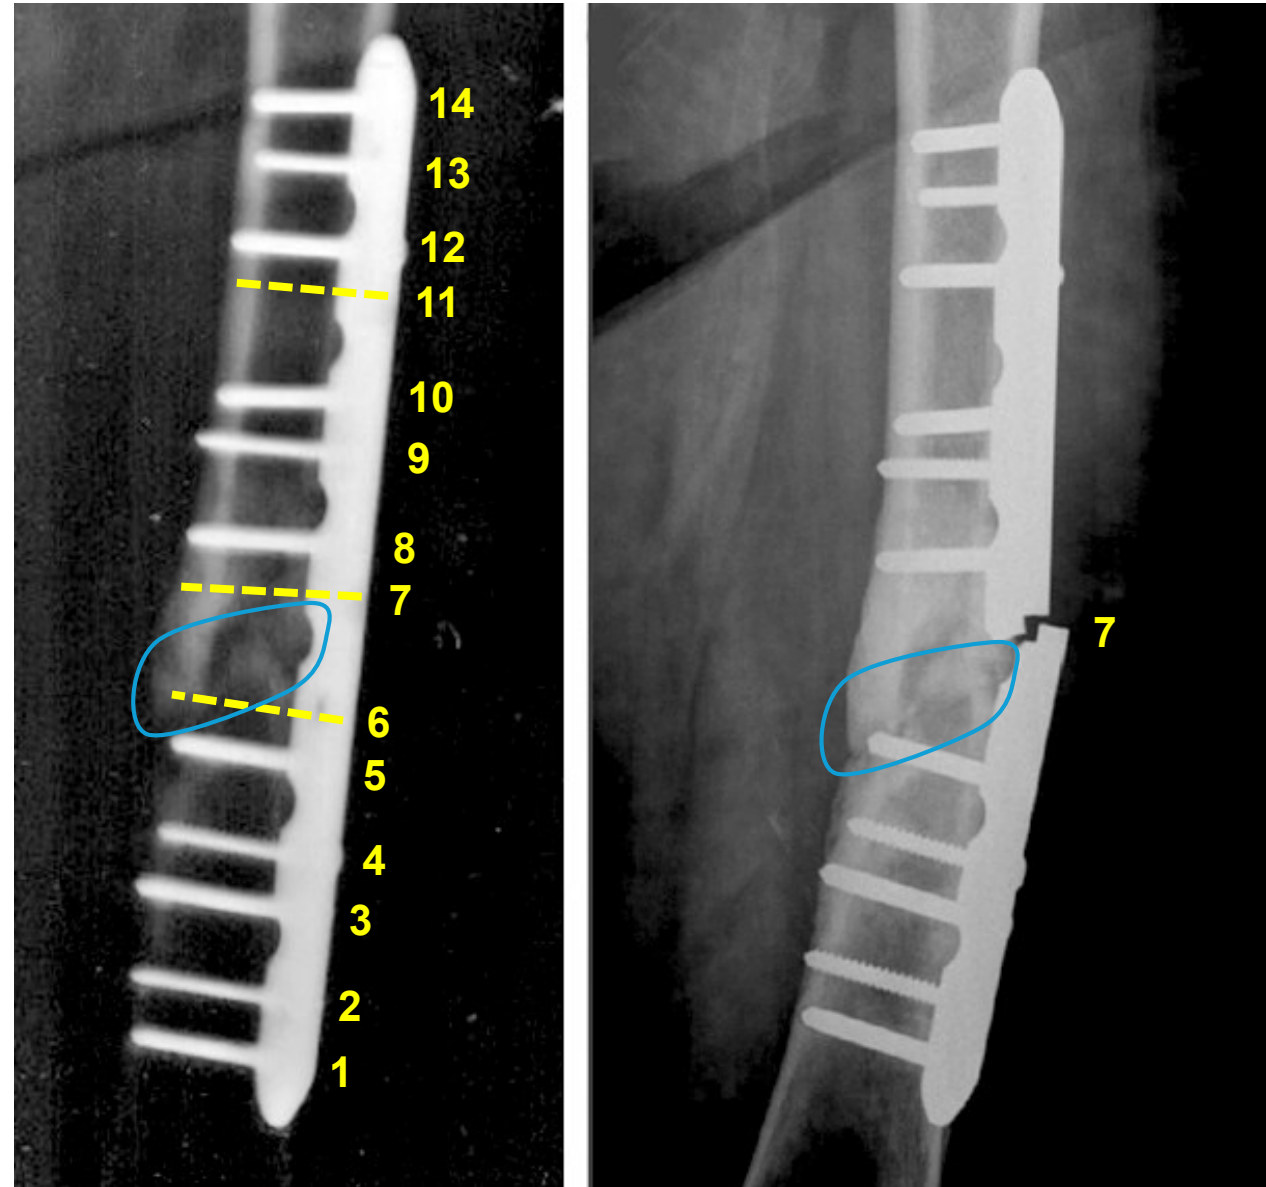
Patient's left femur. Implant fracture 6 months after surgery.

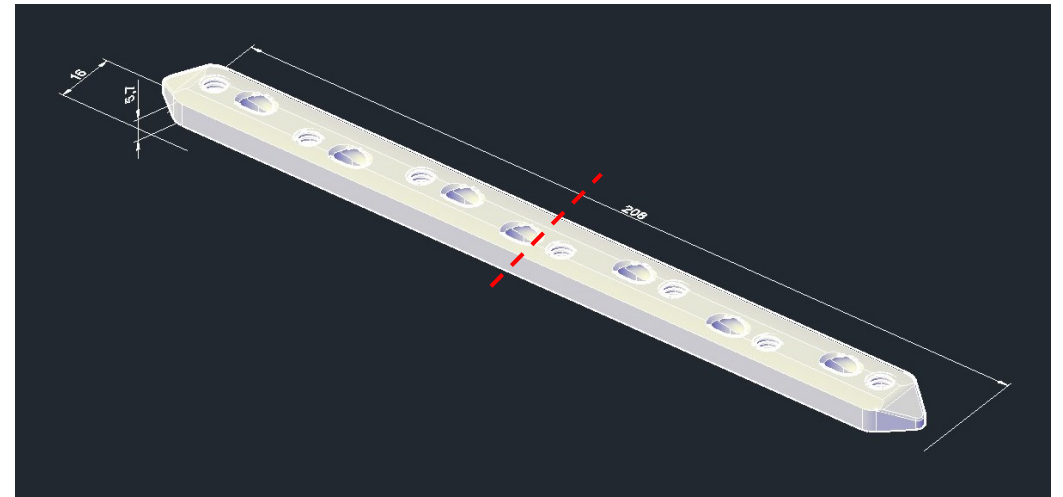
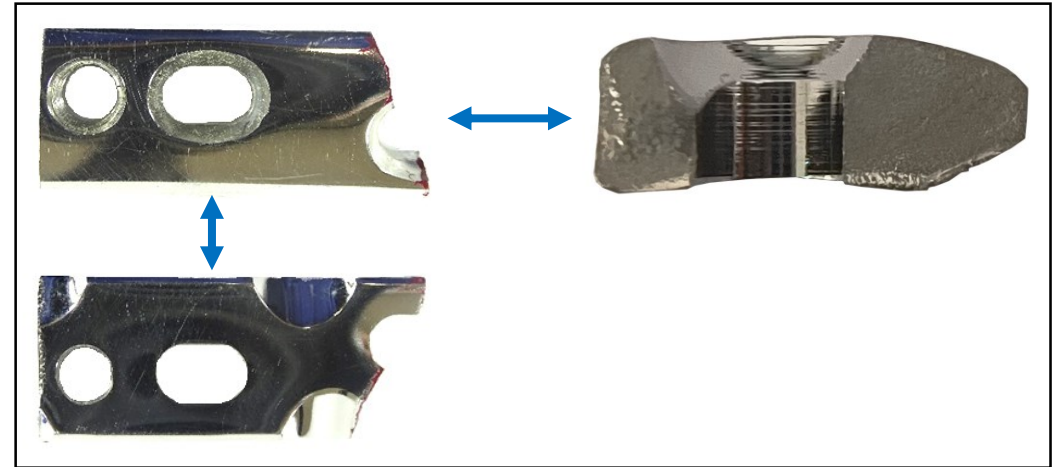
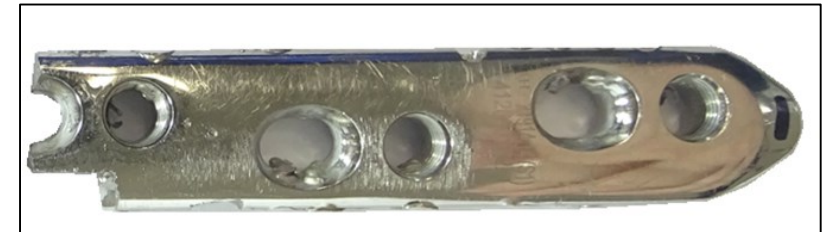
- Stainless steel bone plate - internal fixation device
- 84-year-old, 60 kg, female patient
- Not the first implant to fail
- Only a few parts available for this study. No screws.

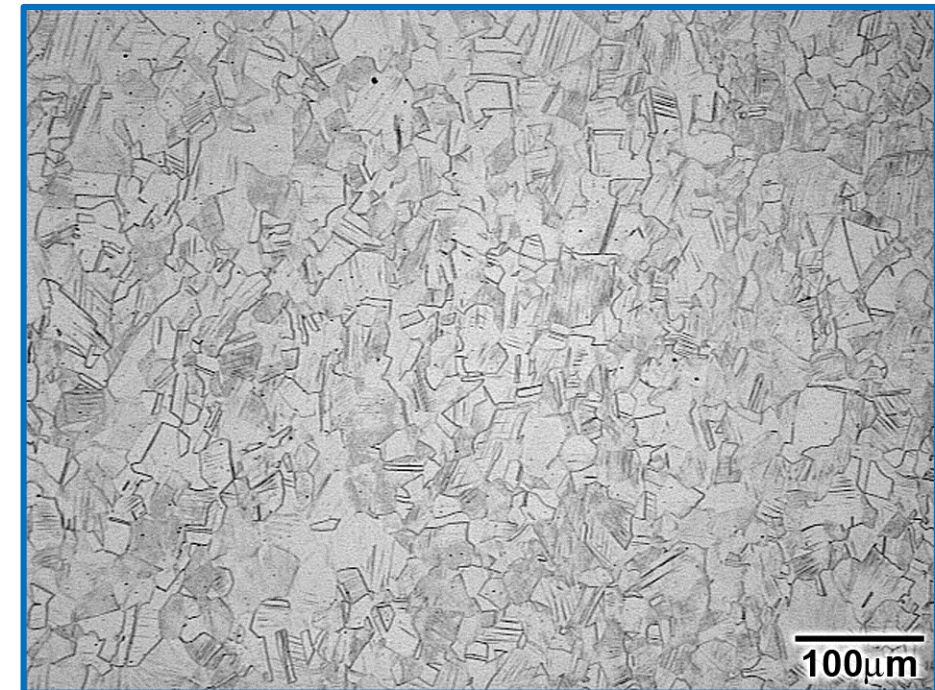
In accordance with ISO 5832-1 requirements
(similar to AISI 316L)

Hardness: (305 ± 10) HV1

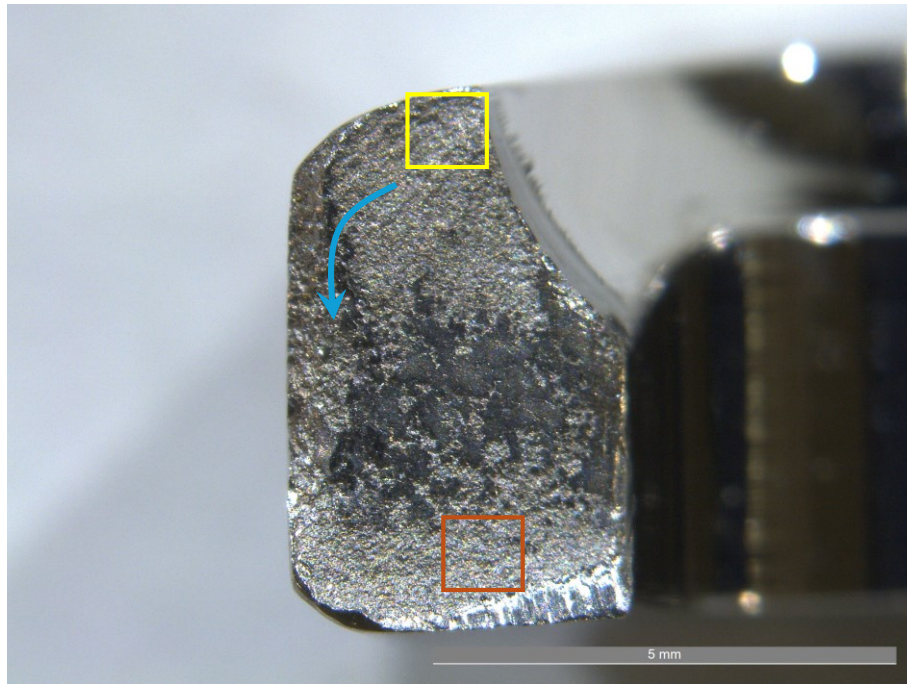
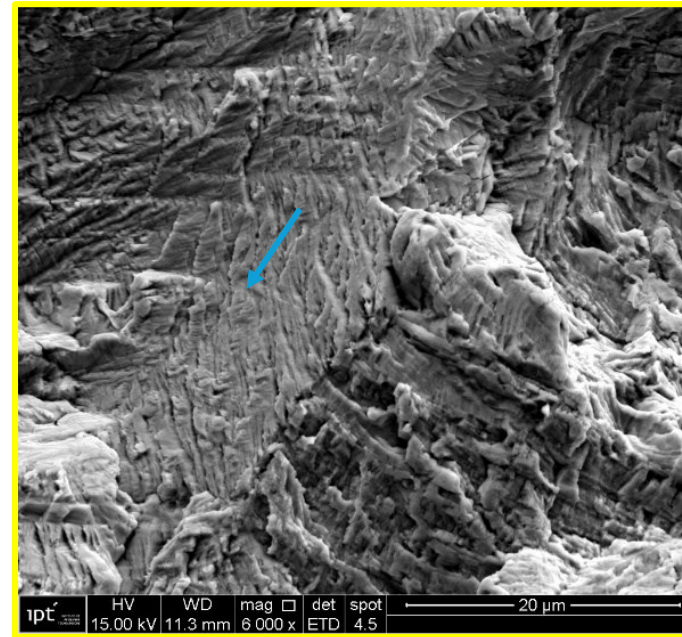
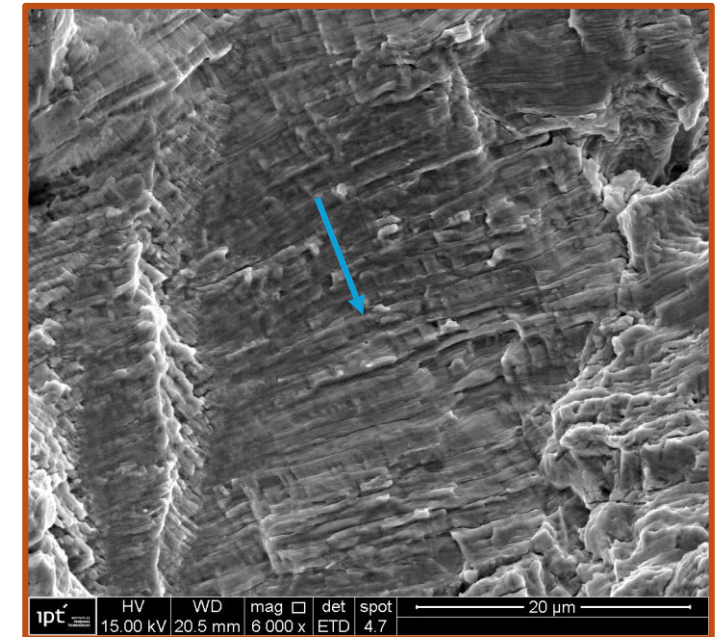
Fatigue crack propagation towards the bottom of the plate (next to the bone)

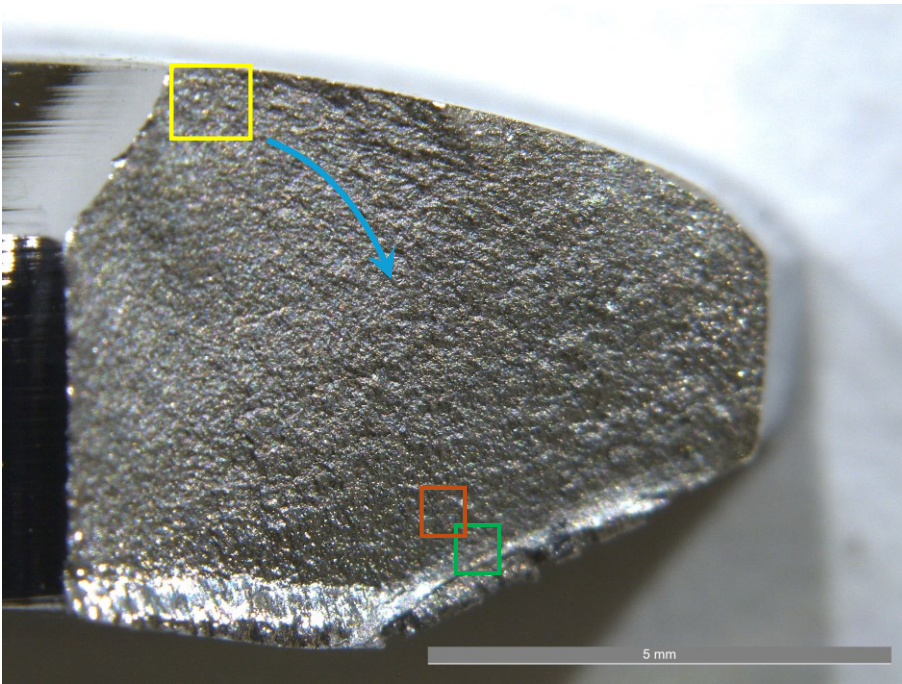
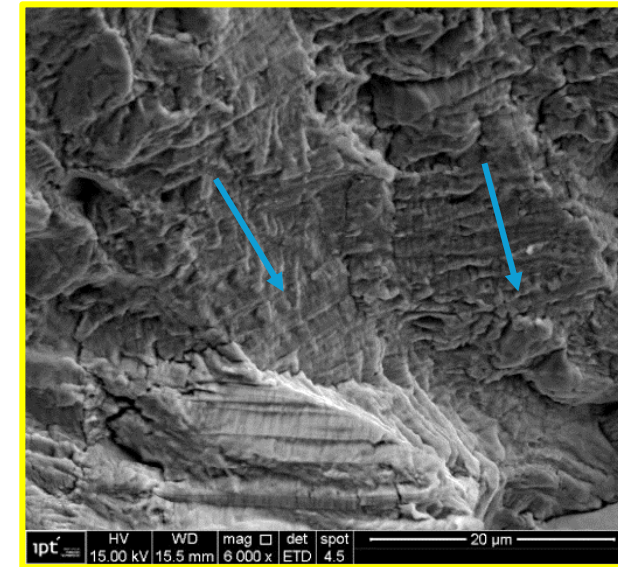
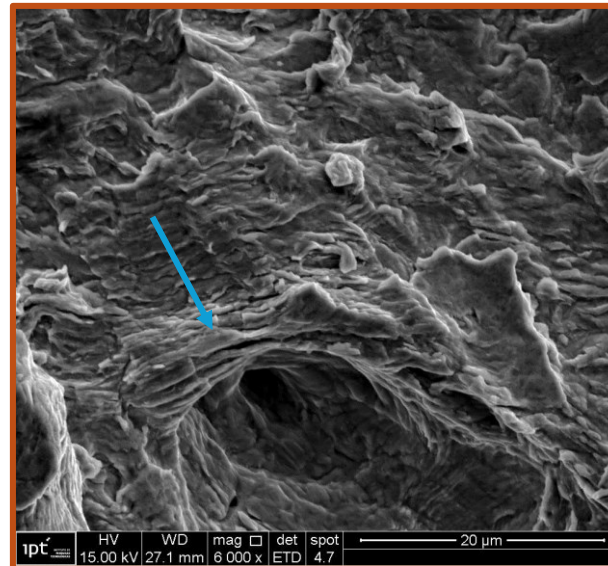
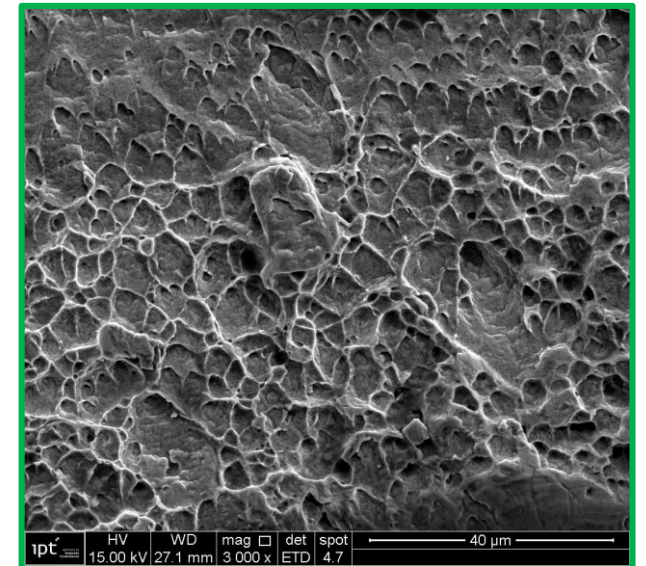
Most of the fracture surface corresponds to stable crack propagation

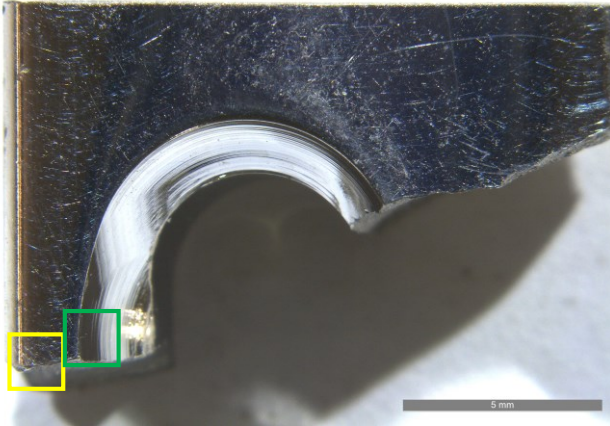
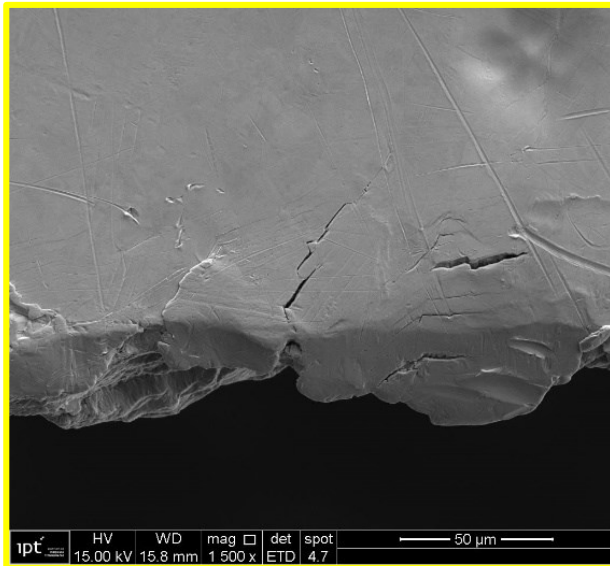
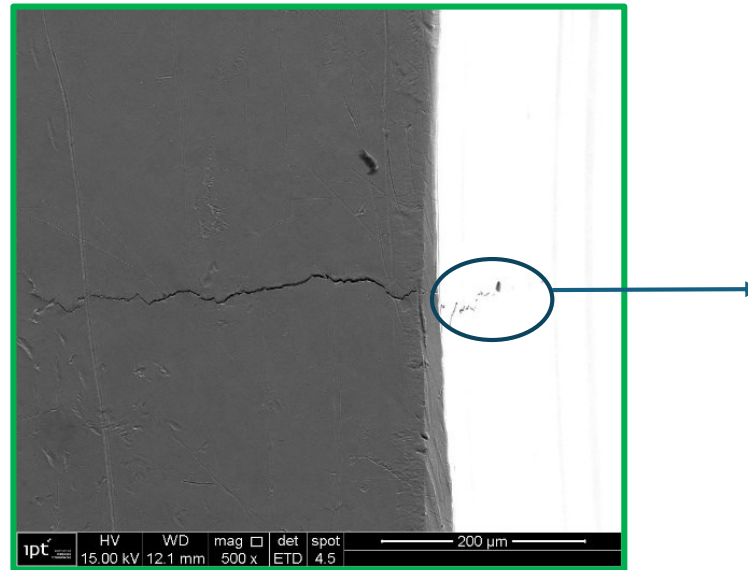
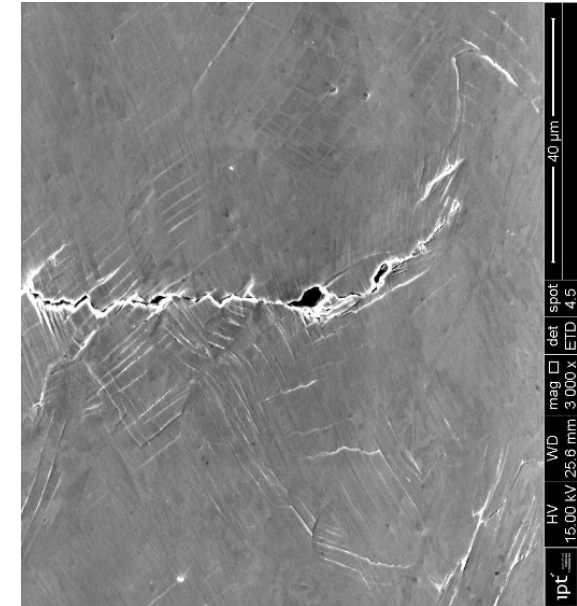
Secondary cracks on the top surface of the implant
(away from the bone)

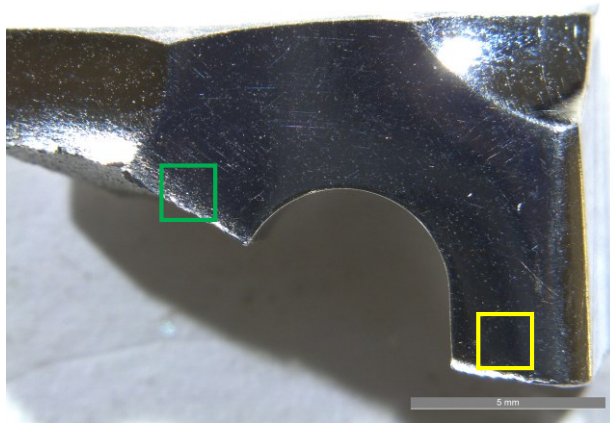
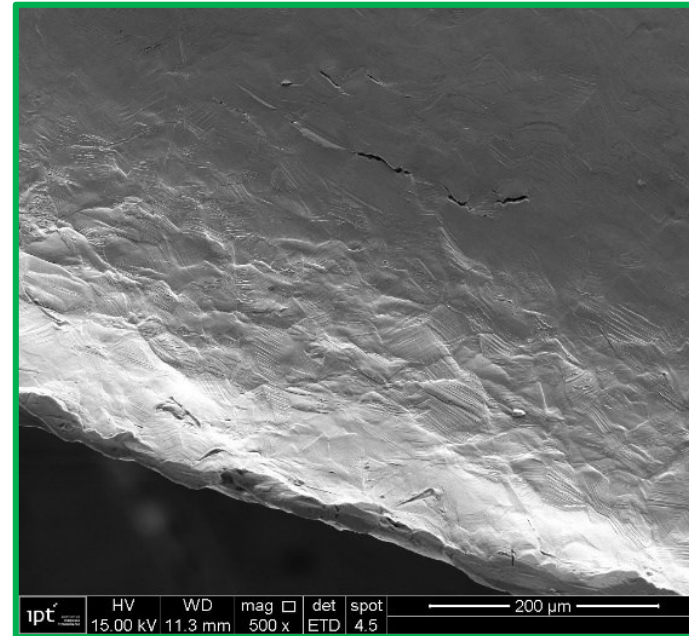
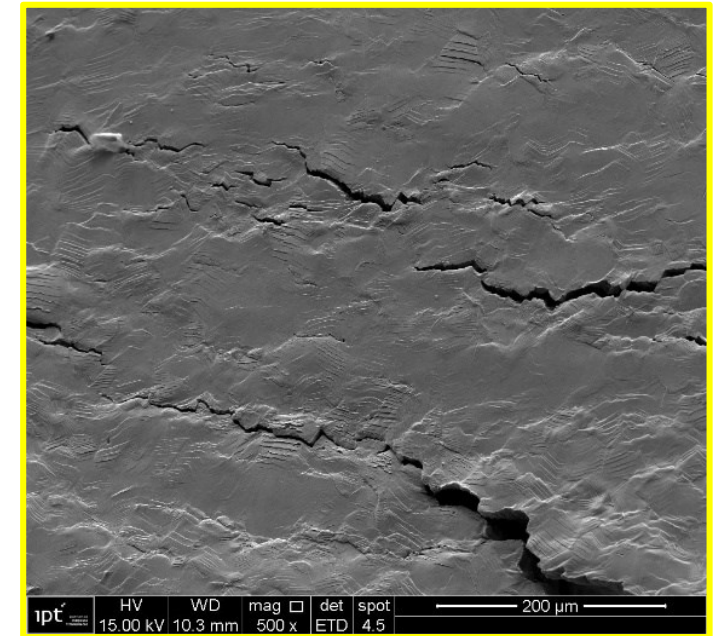
Secondary cracks on the bottom surface of the implant (next to the bone)

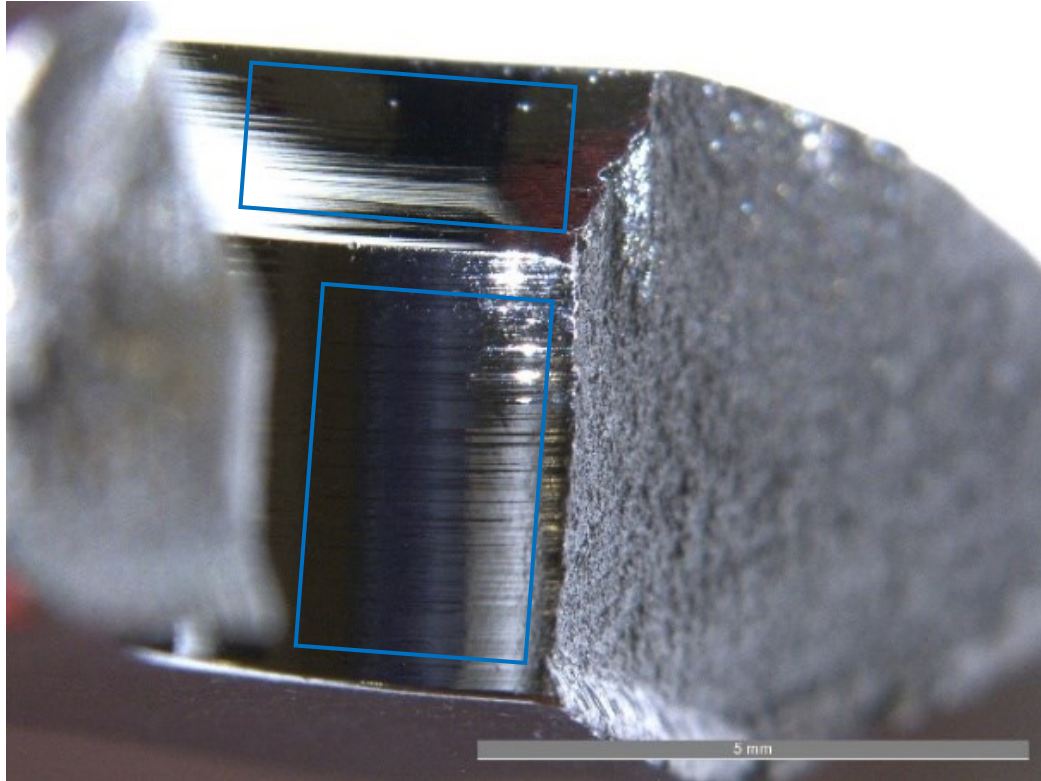
All compression holes had tool marks

Although we could not find evidences directly relating them to fatigue crack nucleation, they are not allowed by:

- ABNT NBR 12932/ASTM F86 (Surface Preparation and Marking of Metallic Surgical Implants)
- ABNT NBR 15676-1/ASTM F382 (Metallic bone plates - Part 1: Requirements).

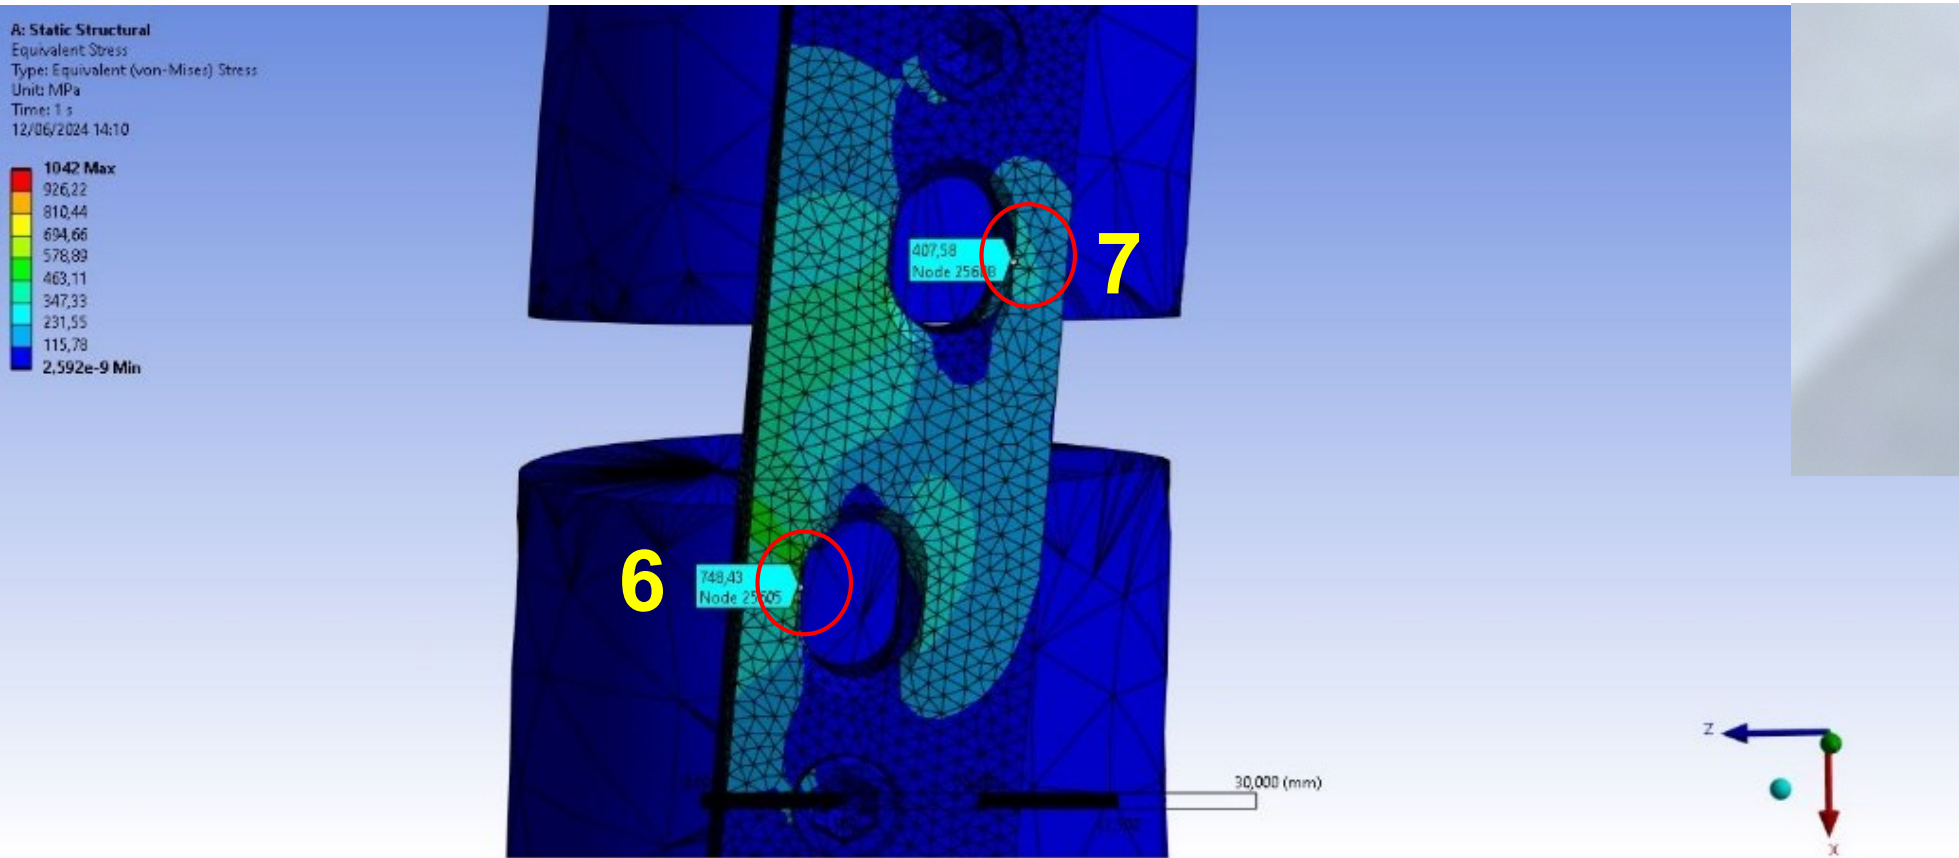
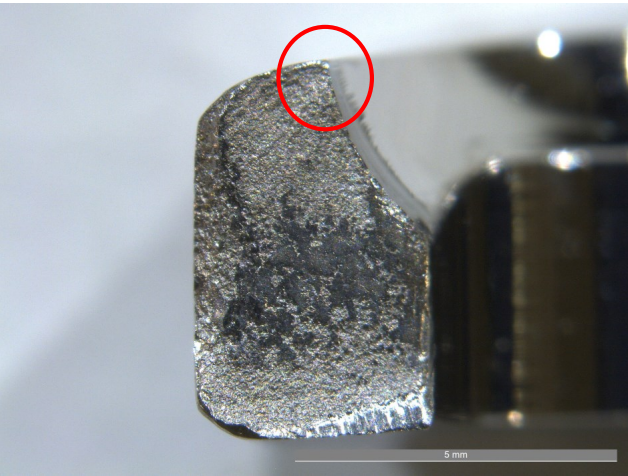
Hole #6: 748 MPa

Hole #7: 408 MPa

Fatigue limit = 394 MPa [2]
 (cold-worked 316L, R = 0)

**Fatigue failure due to excess loading
 (without bone healing) seems possible**
