High resolution techniques for geoenvironmental characterization of a site with methane in the subsoil

*Trabalho apresentado no INTERNATIONAL
CONTAMINATED SITE REMEDIATION
CONFERENCE, CLEAN UP, 7th., 2017,
Melbourne. Proceedings...*

HIGH RESOLUTION TECHNIQUES FOR GEOENVIRONMENTAL CHARACTERIZATION OF A SITE WITH METHANE IN THE SUBSOIL

¹Geoenvironmental Technologies Center - CTGeo, Institute for Technological Research – IPT,
São Paulo, BRAZIL

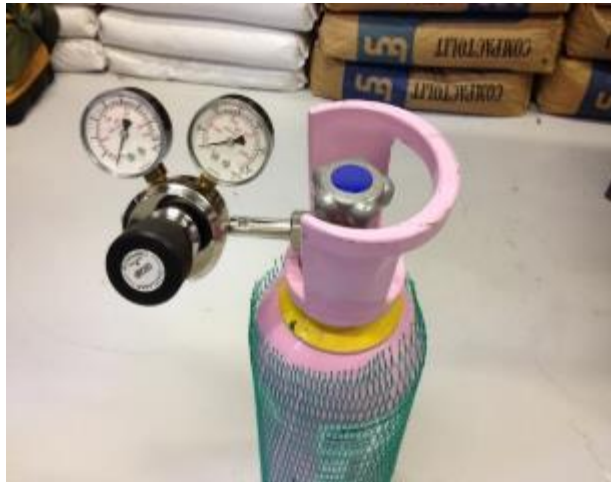
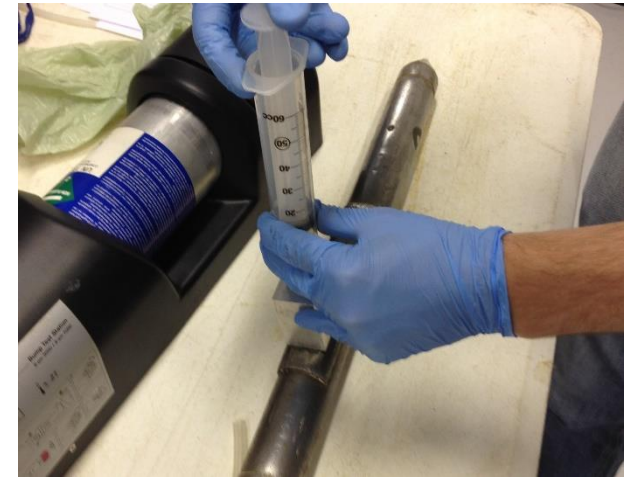
Preparation and injection of the gaseous mixtures in the MIP system

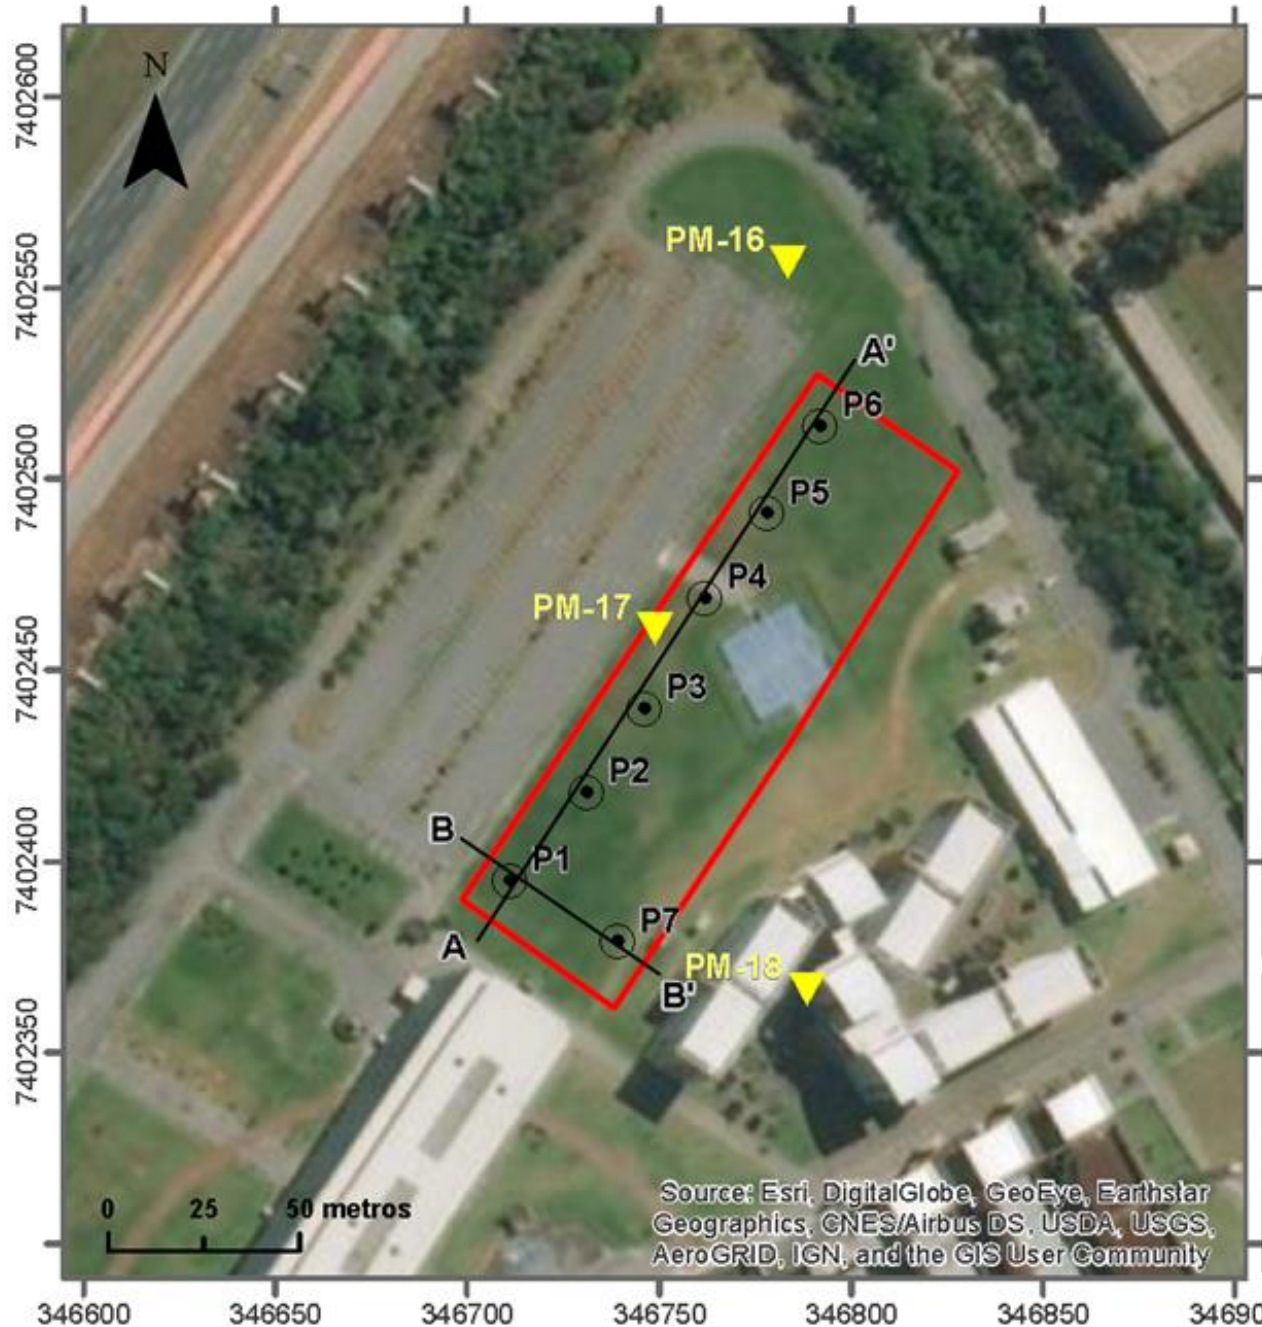
- Cluster of tests
- ▼ Monitoring well
- ▭ Study area
- A—A' Cross Section

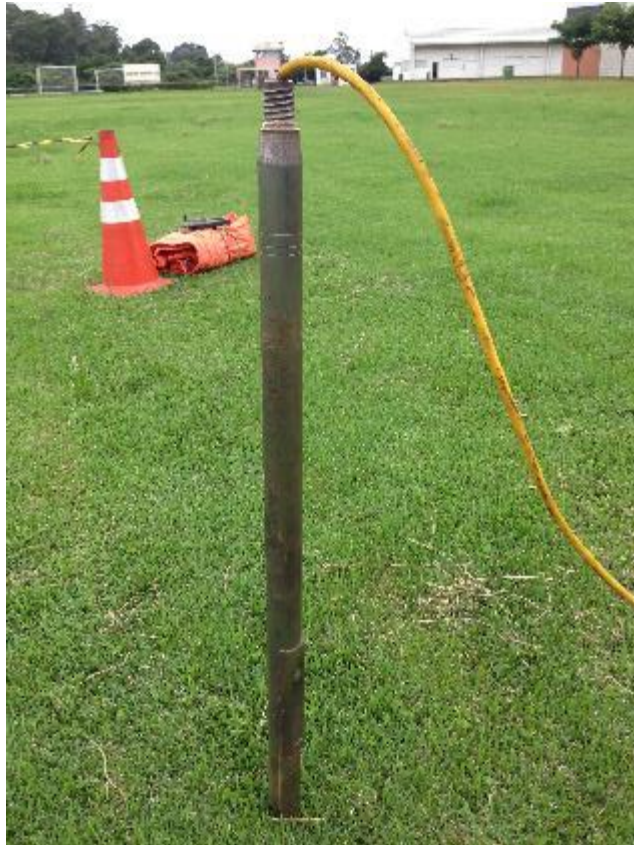
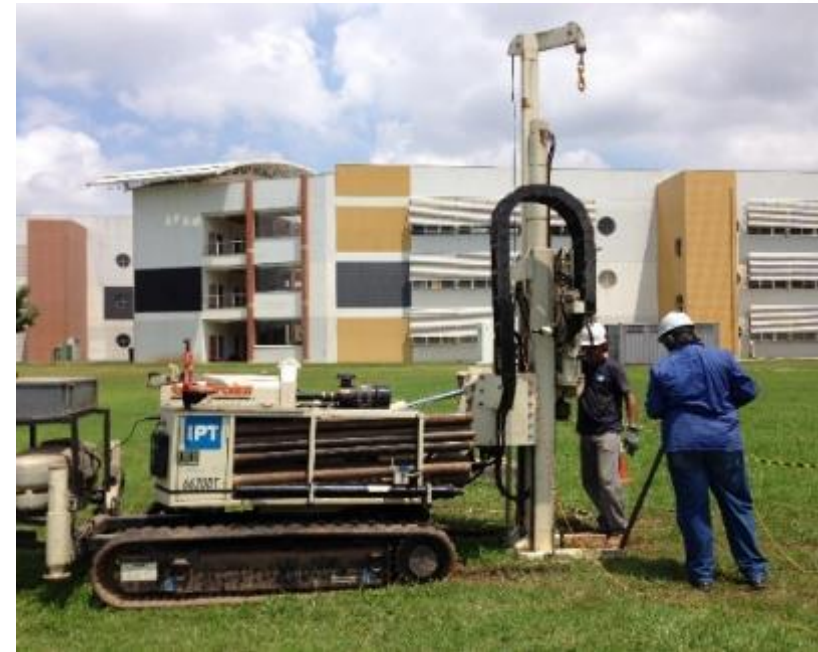
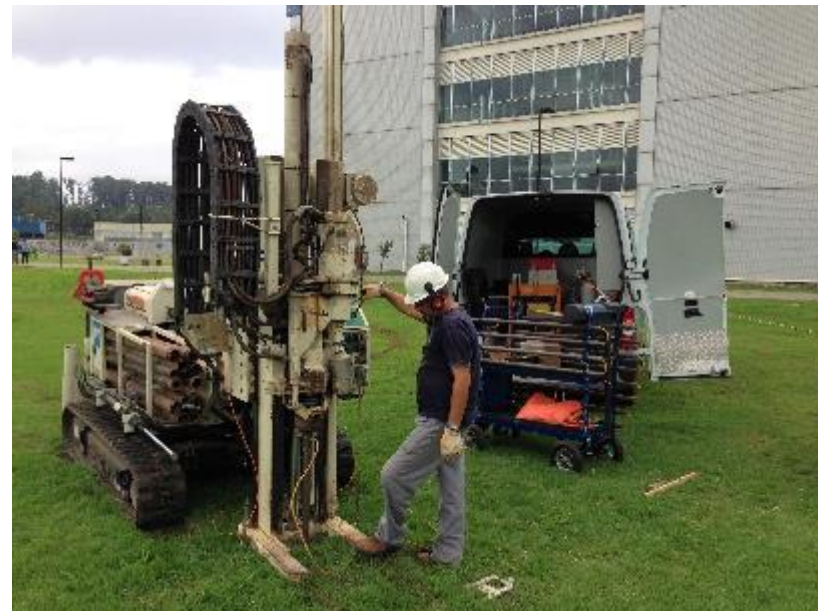
Field work with the MIP system

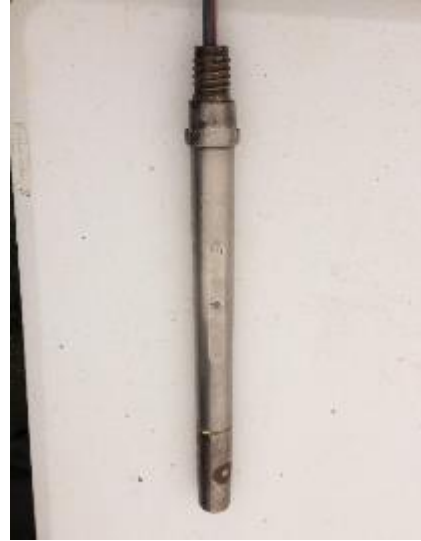
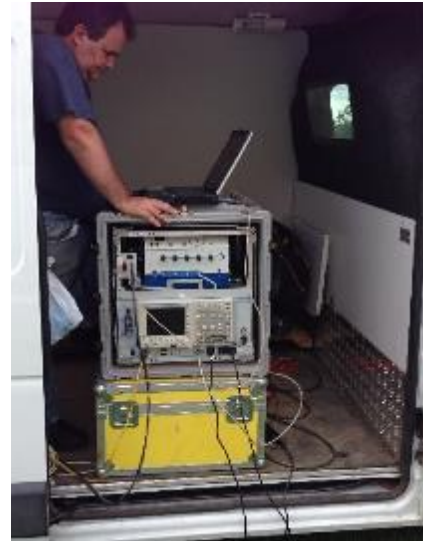
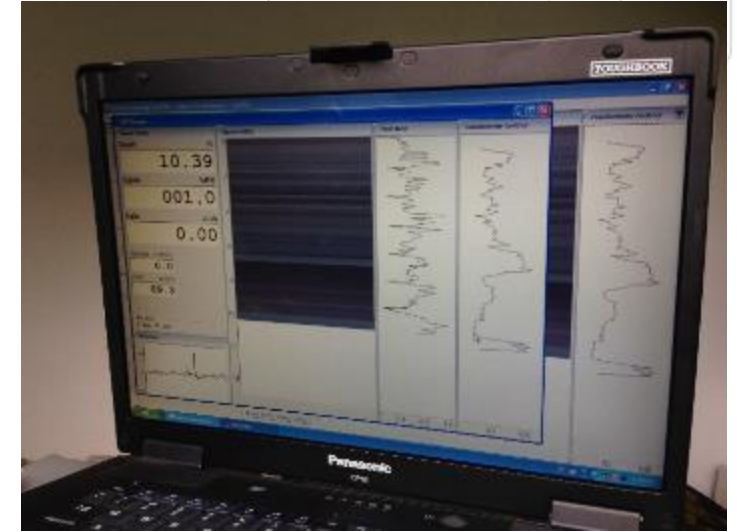
Tests with the Soil
Color Optical
Screening Tool
(SCOST)

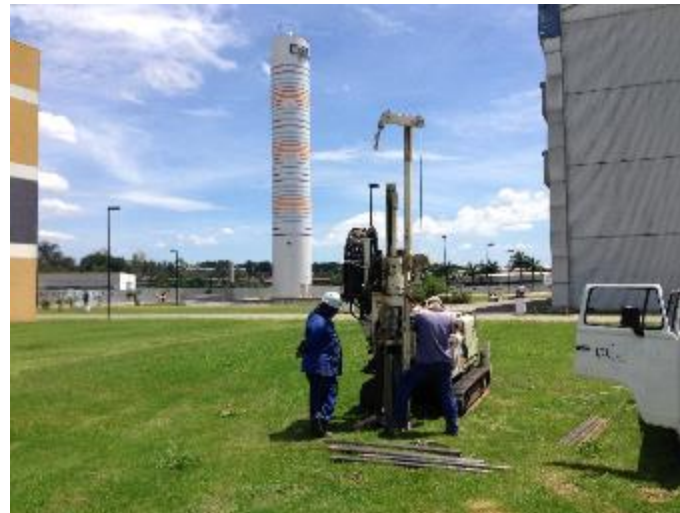
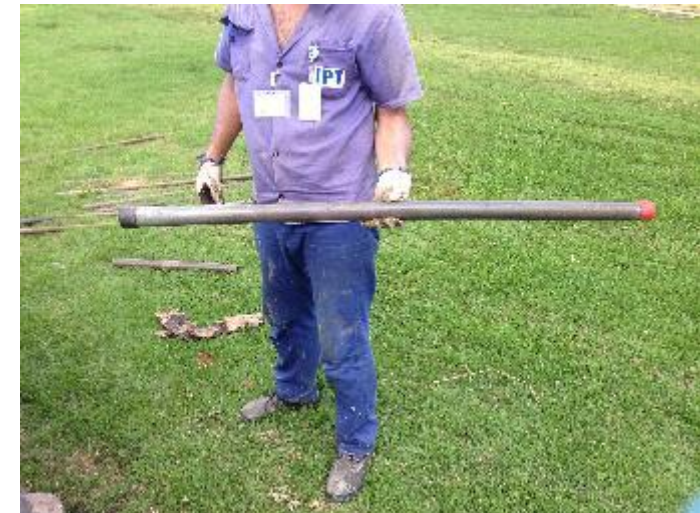
Direct push (whole
core) soil sampling

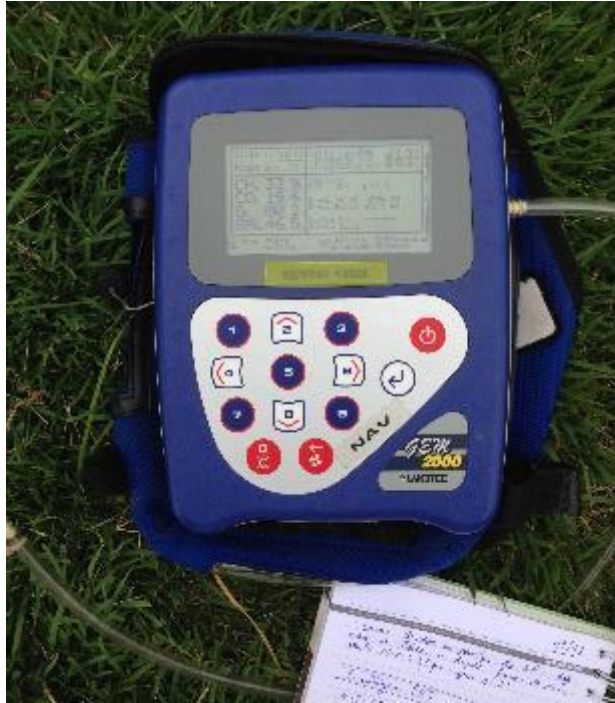
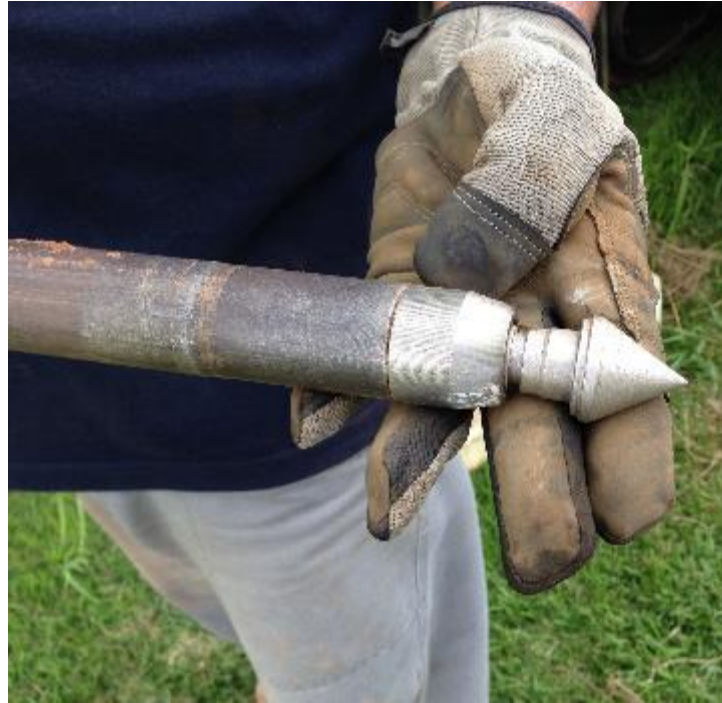
Soil Gas sampling with Post Run Tubing System (PRT)

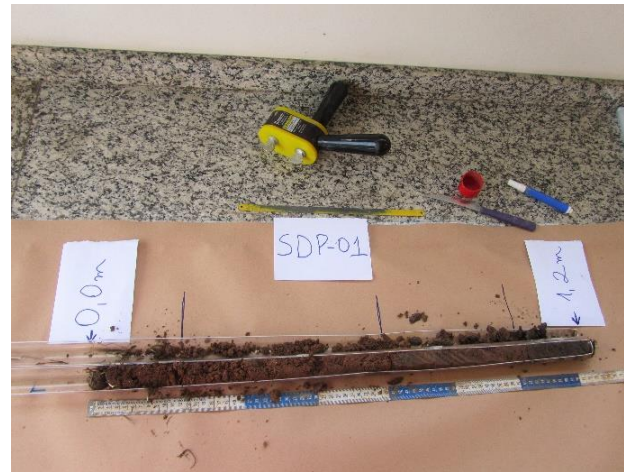
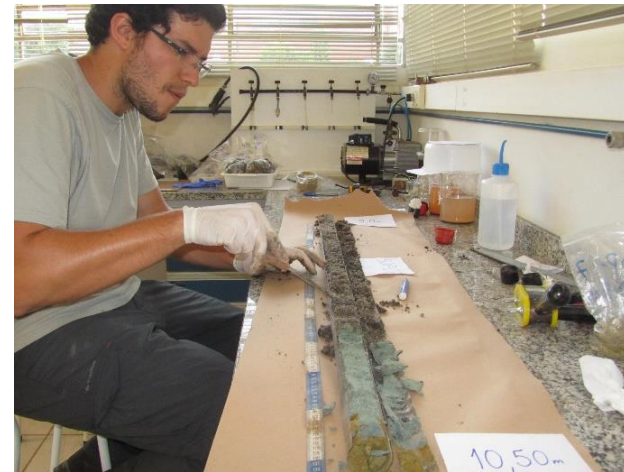
Soil description and sample collection

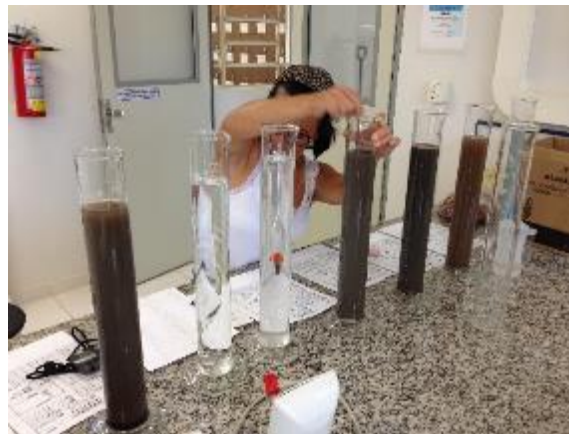
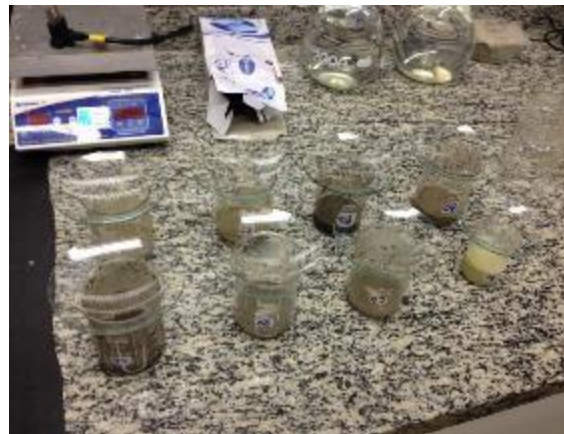
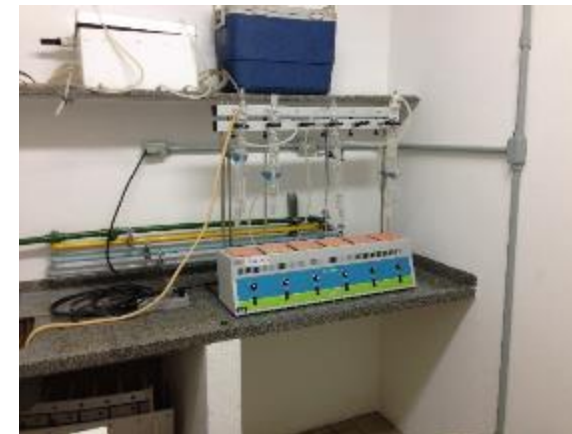
Grain size, organic matter and fraction of organic carbon analysis

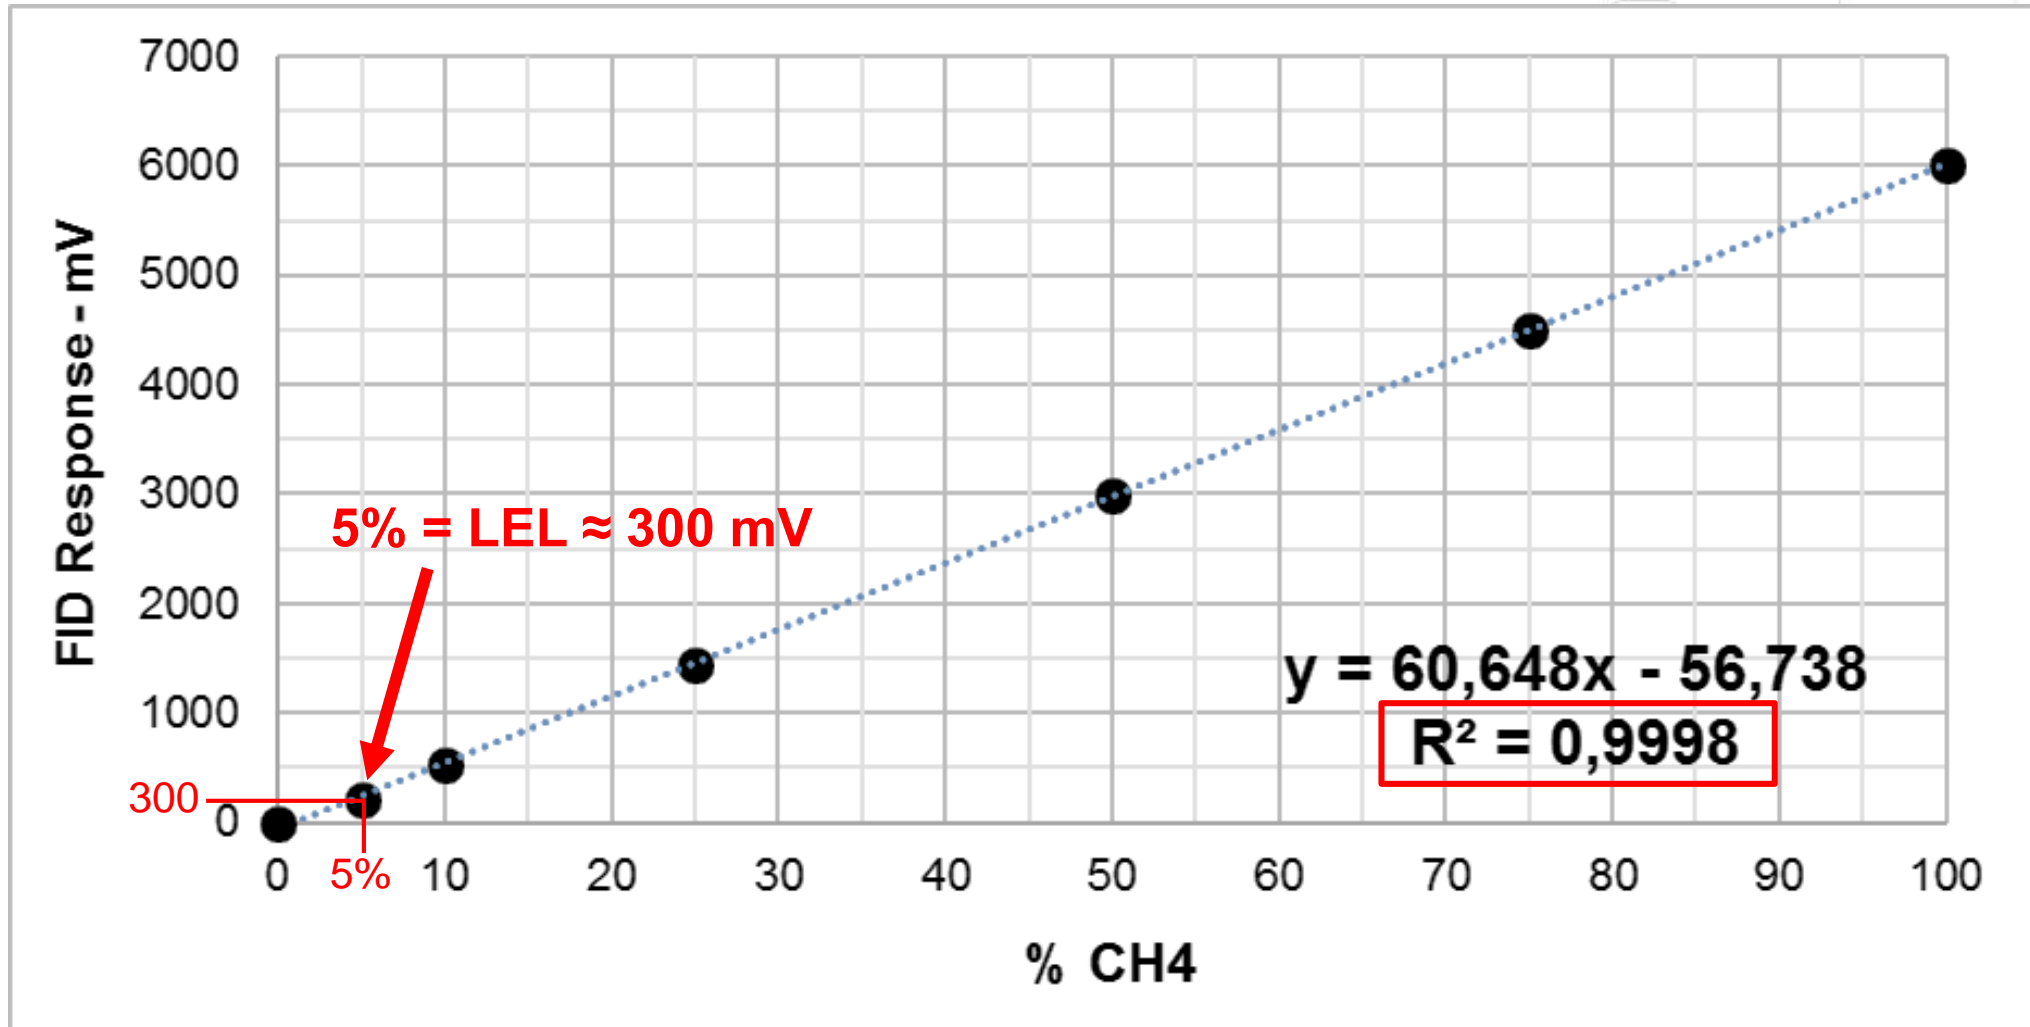
Bench Tests – Response Curve

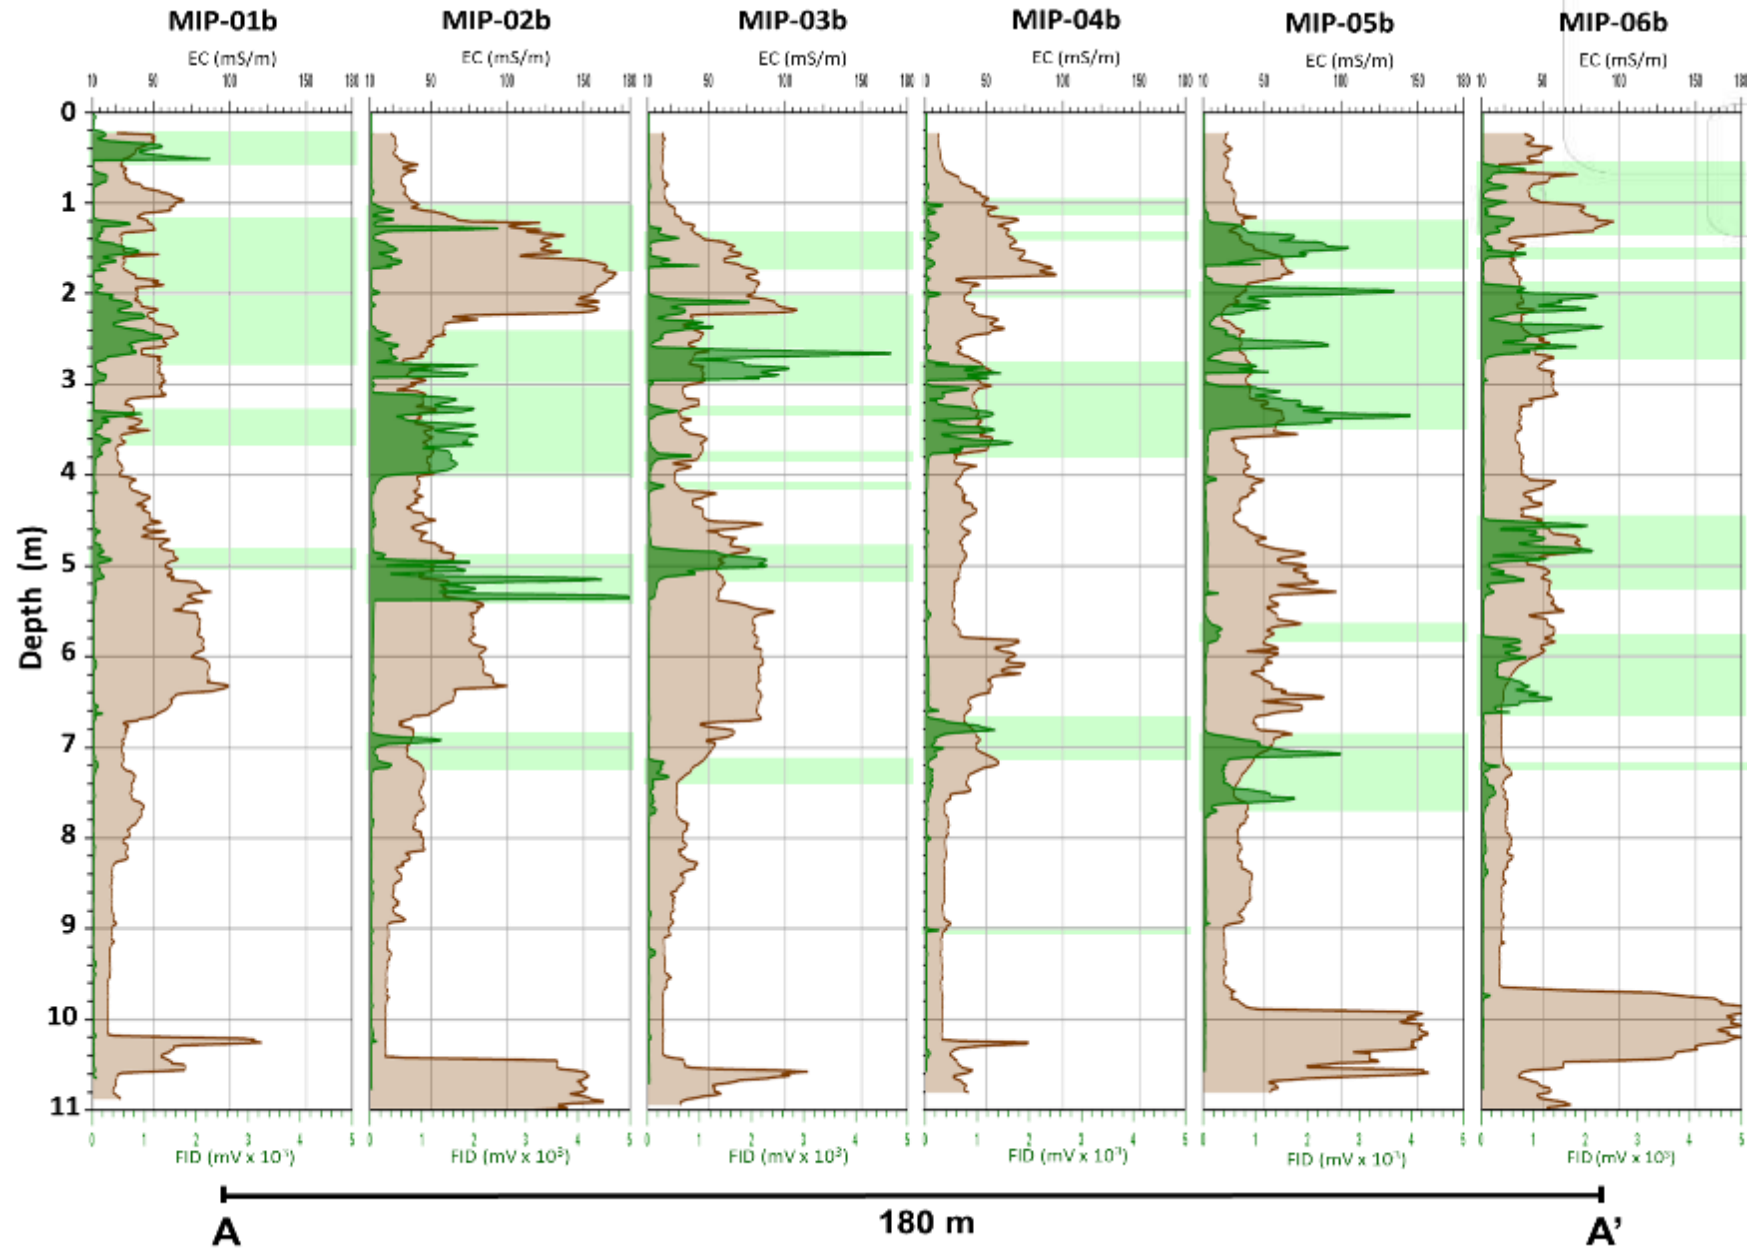
MIP Field results - FID response to CH₄

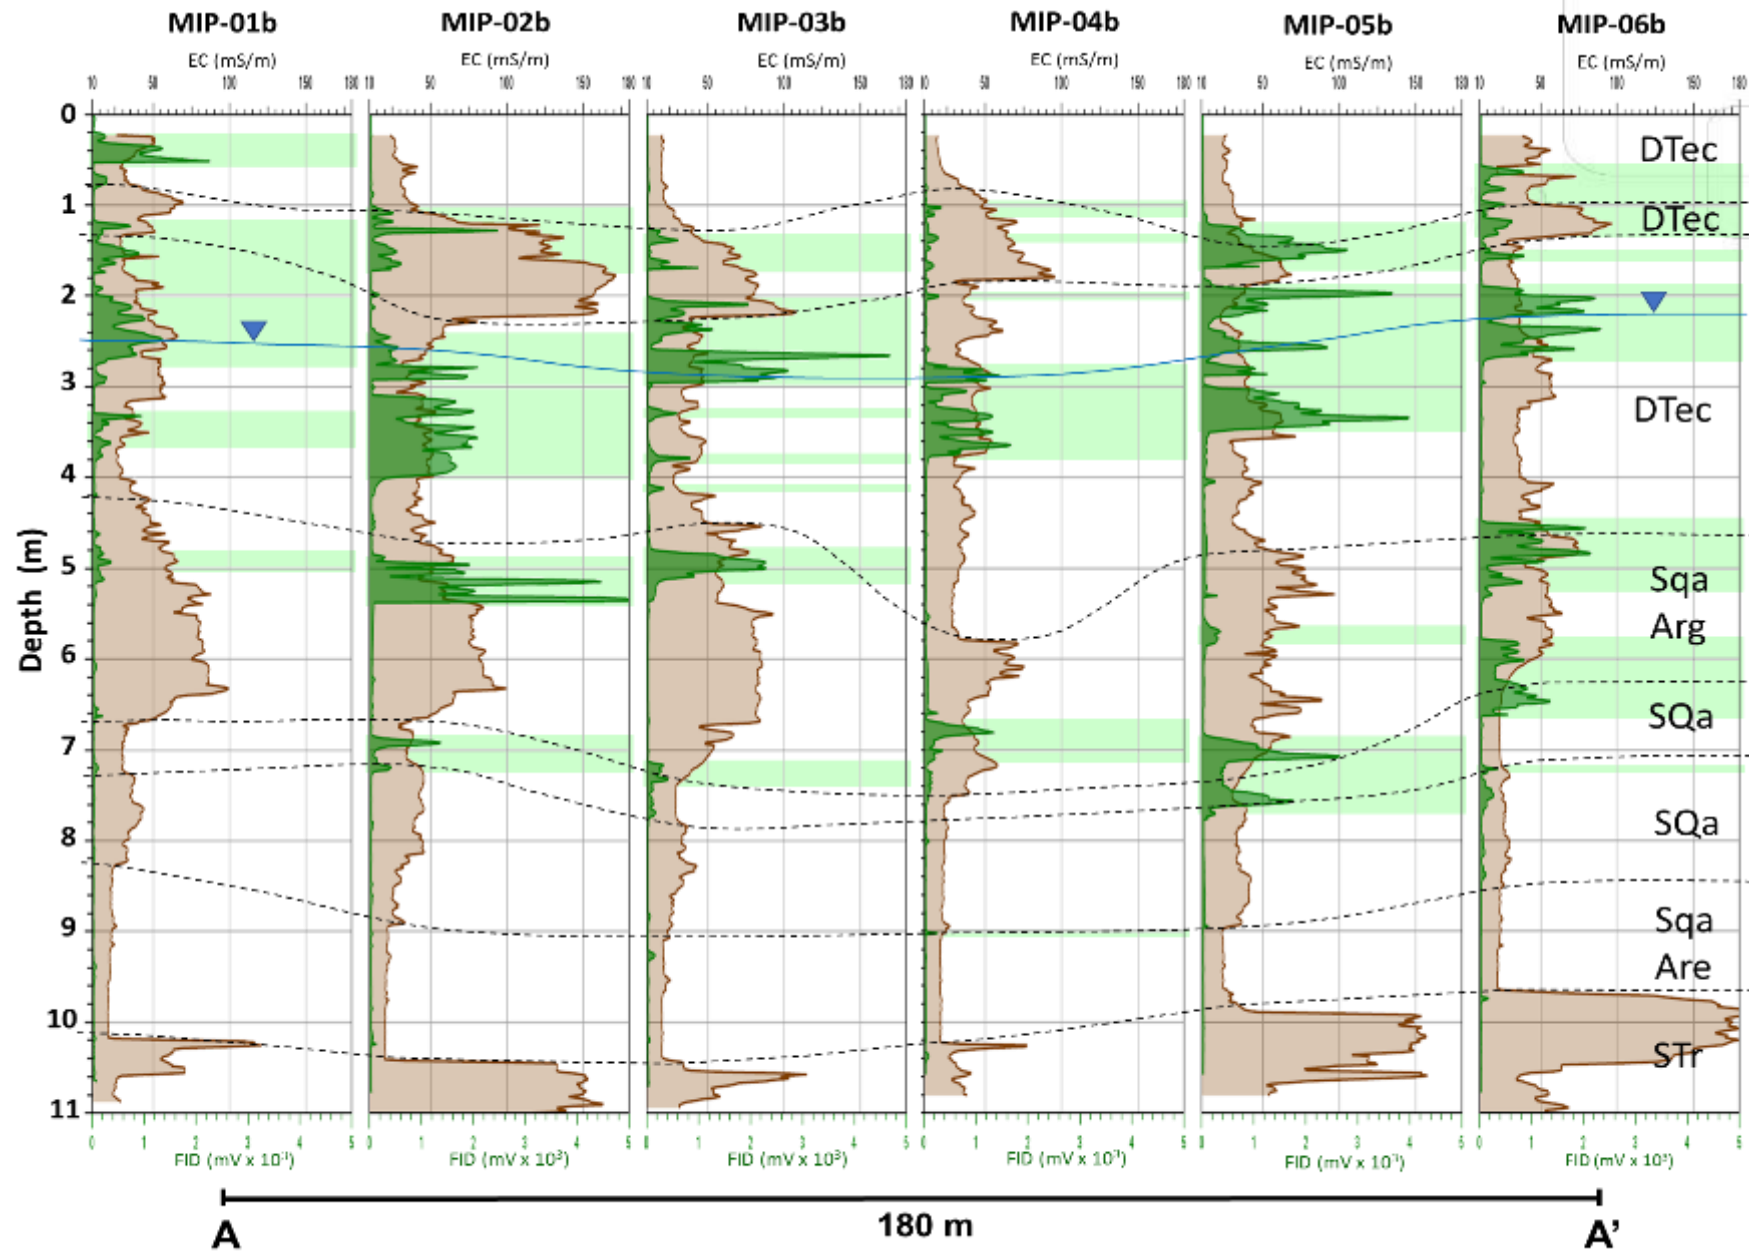
MIP Field results - FID response to CH₄

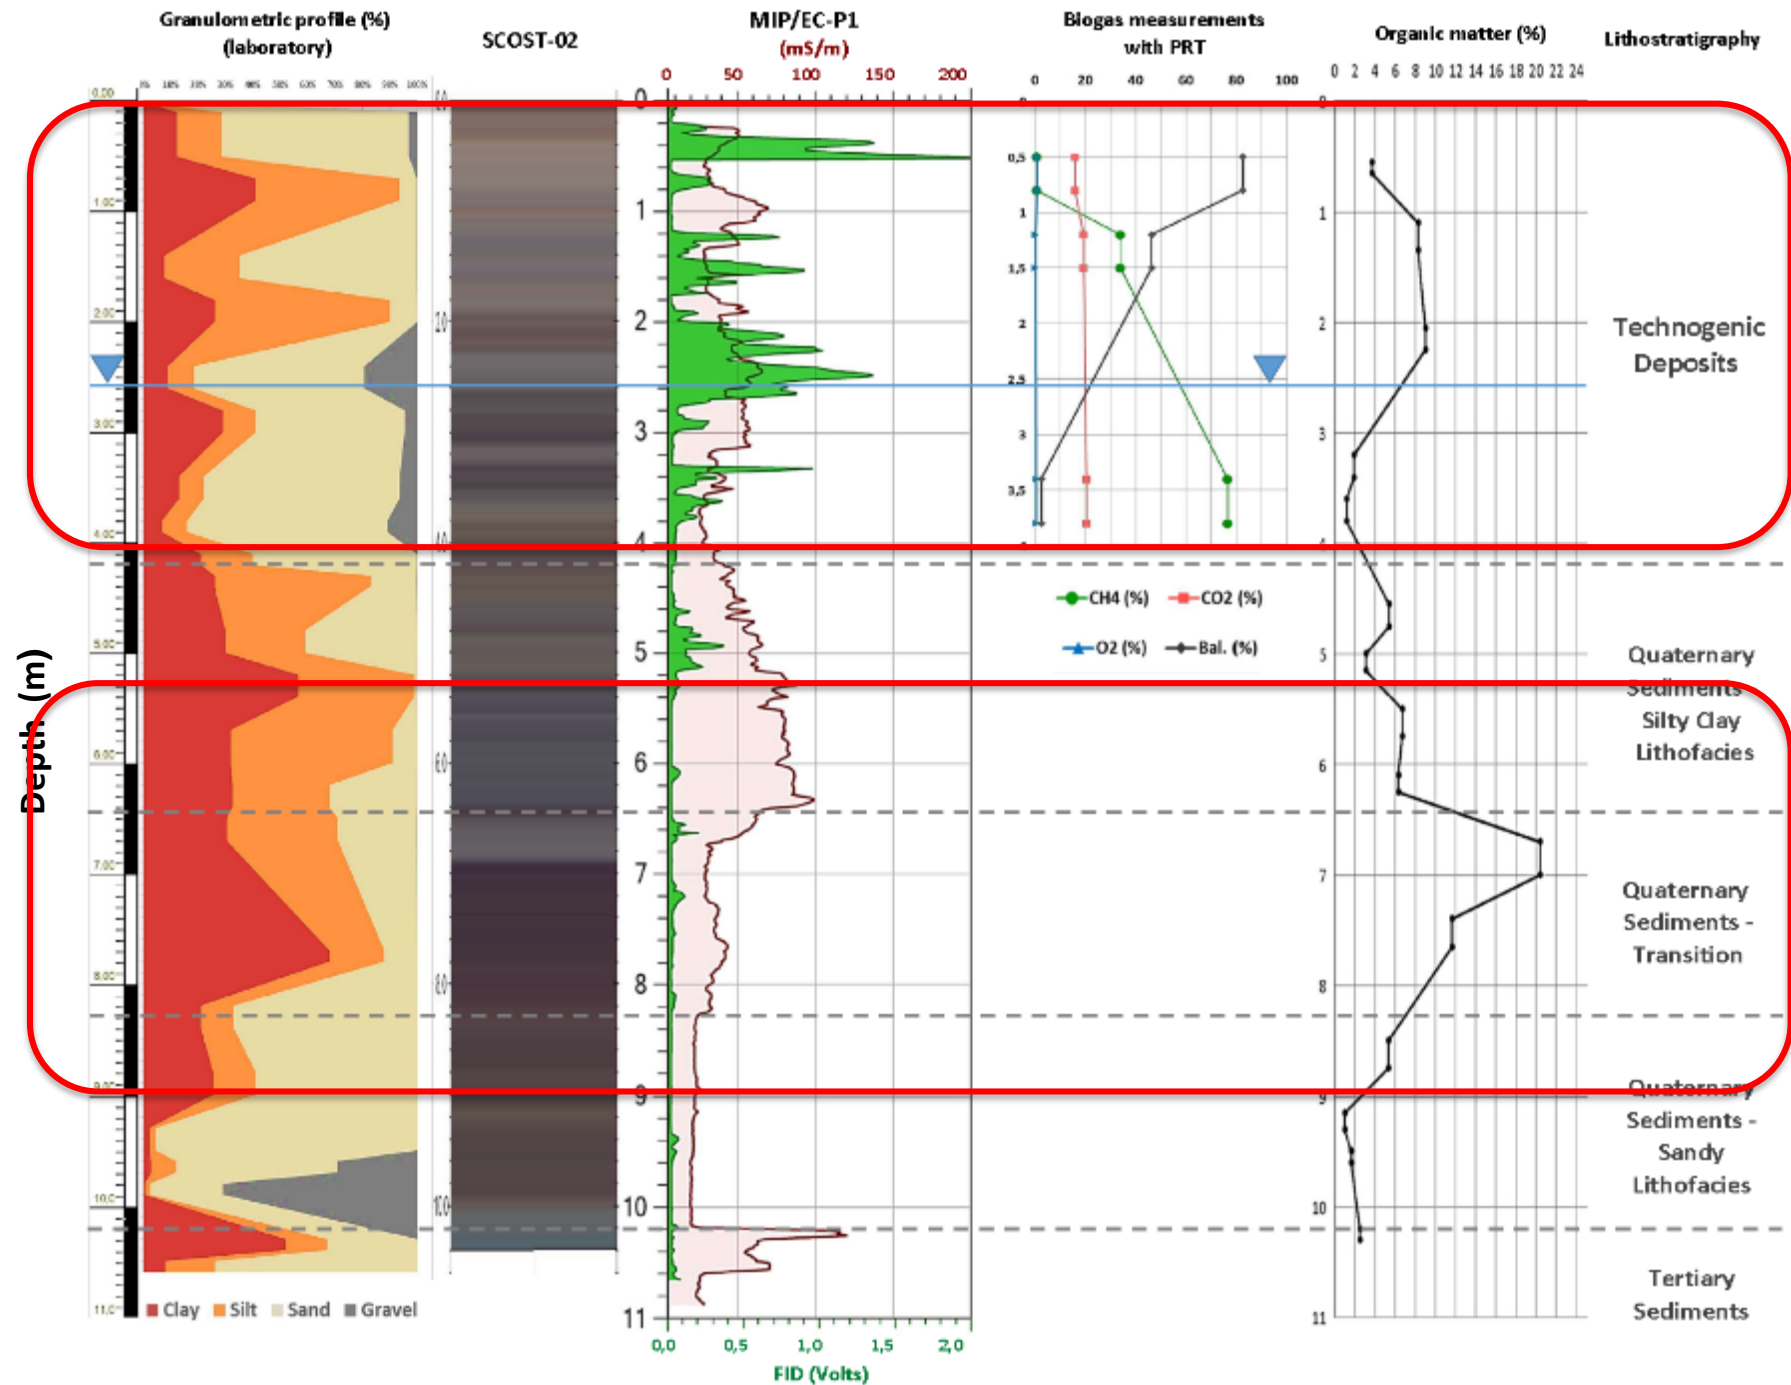
Conceptual Site Model (CSM)

Integration of field and laboratory results

- MIP/EC can provide high resolution response for:
 - Soil electrical conductivity - Lithostratigraphy;
 - Detection and mapping of METHANE in the subsurface (FID);
- Auxiliary field and laboratory techniques also provided valuable information to support the interpretation and validation of the results;
- HRSC techniques contributed to achieve a detailed CSM for the presence of methane in the study area.
