**Application of machine learning techniques for identifying emergency conditions in rainwater galleries**

*Palestra apresentada no IBERO-LATIN CONGRESS ON  
COMPUTATIONAL METHODS IN ENGINEERING, 44., 2023, Porto  
17 slides.*

# APPLICATION OF MACHINE LEARNING TECHNIQUES FOR IDENTIFYING EMERGENCY CONDITIONS IN RAINWATER GALLERIES

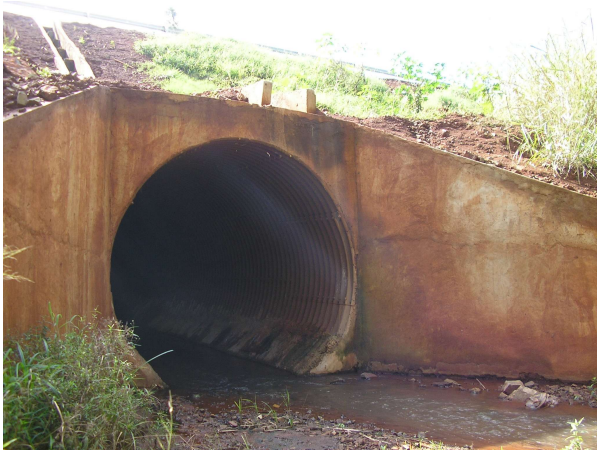
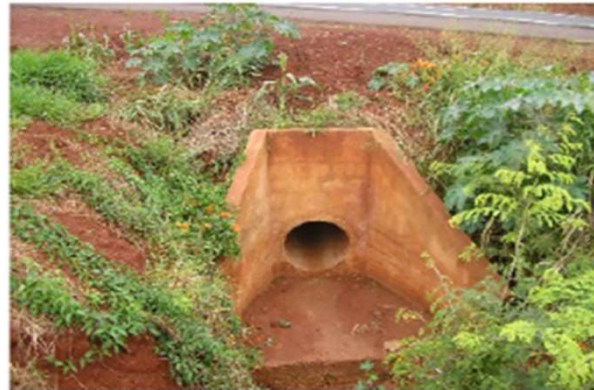
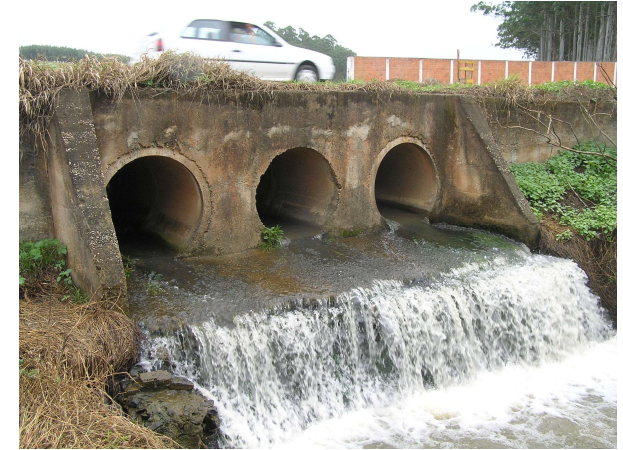
Figure 1. Examples of rainwater gallery inspected (source: IPT)

- Focusing on the study and improving operational procedures in visual inspections (Figure 1), the relevance of the input dataset with 5 features was verified.

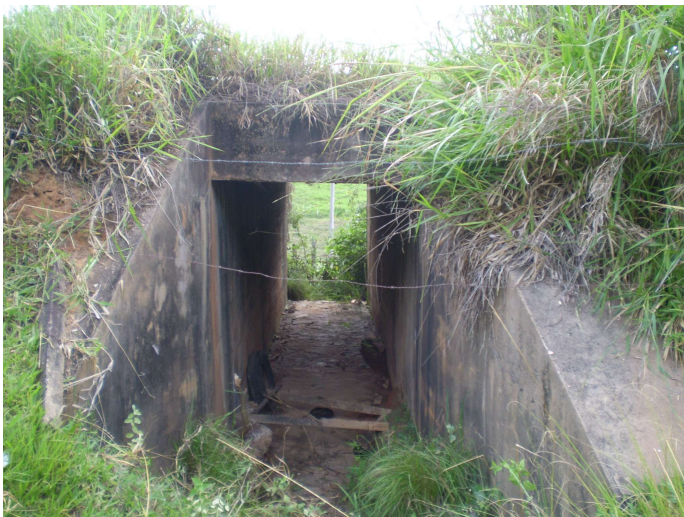
Cattle crossing

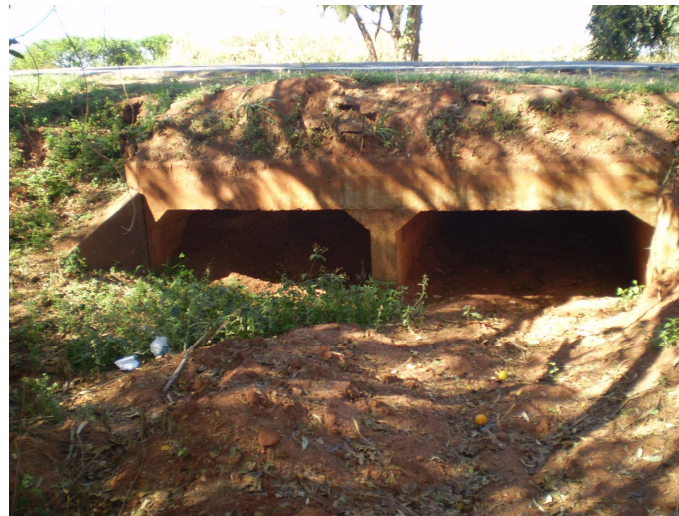
Rainwater gallery with two cells silted (Type 1)

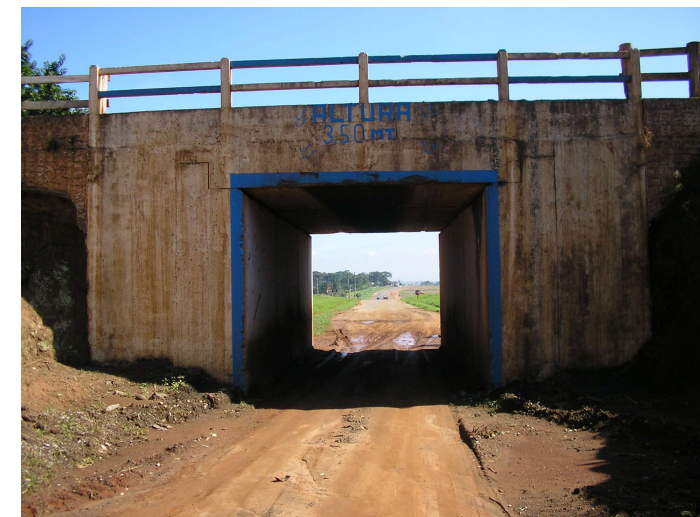
Underpass with a span of less than 5 meters

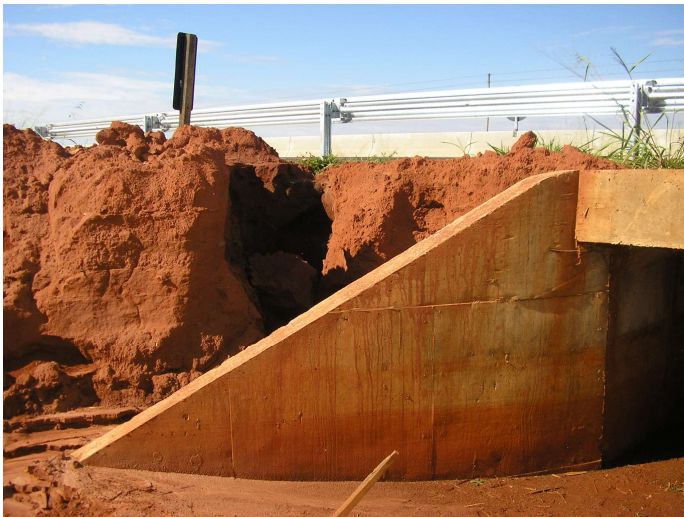
Area with severe erosion on slopes (Type 5)

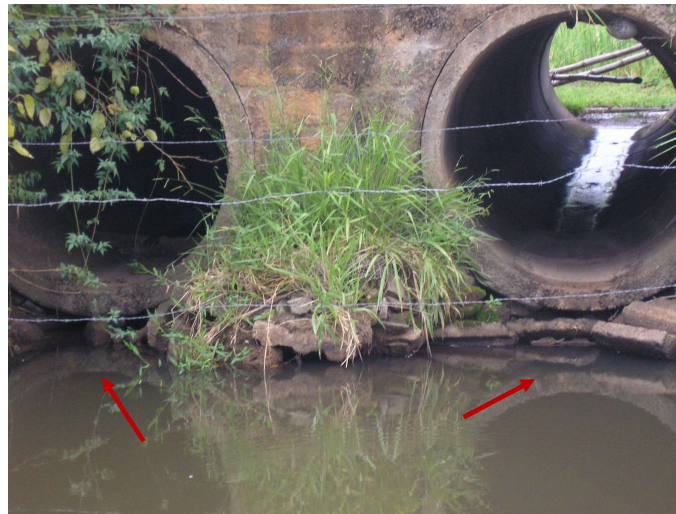
Arrows pointed erosion under gallery (Type 4)

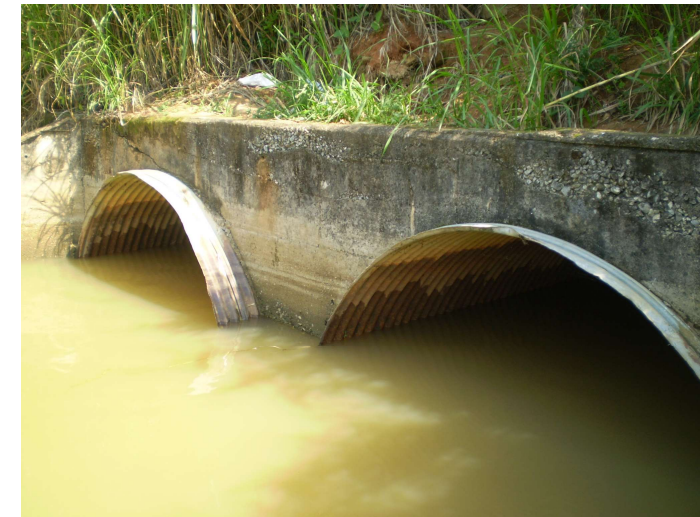
Flood gallery (Type 1)
