**Evaluation of test methodologies for assessing SCC-CO2 in flexible pipes.**

*Palestra apresentada no LATINCORR &  
INTERCORR 2023, Rio de Janeiro 123  
slide.*

## Evaluation of test methodologies for assessing SCC-CO<sub>2</sub> in flexible pipes

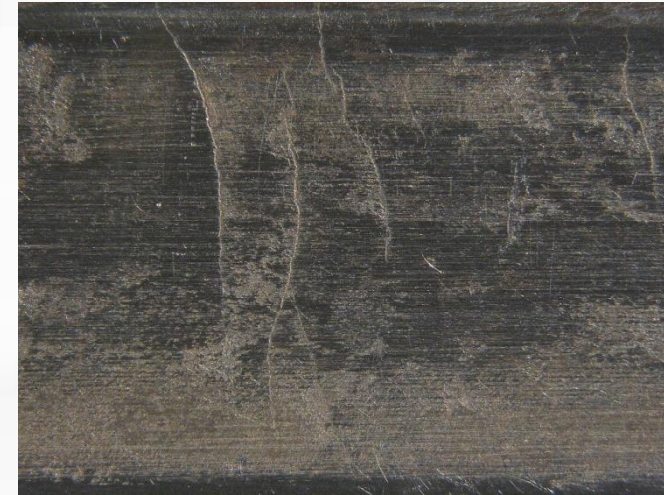
CO<sub>2</sub> Stress Corrosion Cracking may cause unexpected and catastrophic failure of a flexible pipe, leading to production losses and environmental accidents.

*Causes*

- Environment containing H<sub>2</sub>O and CO<sub>2</sub>;
- Static, cyclic or residual stress on pipe;
- Time;
- Susceptible material.

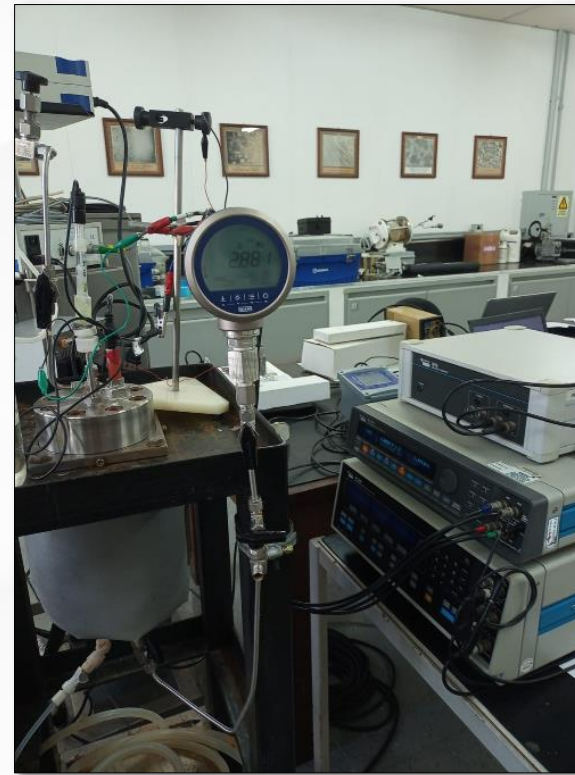
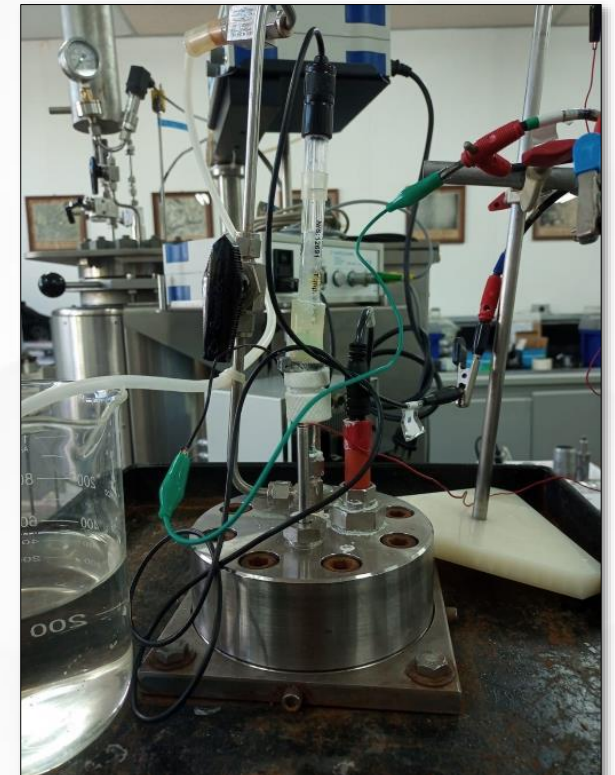
- Environment: simulated ocean water (ASTM D1141:2021) at 40 °C, 10,6 barg of CO<sub>2</sub>, V/A of 1 mL/cm<sup>2</sup>
- Corrosion rate was monitored by LPR until  $i_{corr} = 3.10^{-6}$  A/cm<sup>2</sup> (pseudo passivation time)

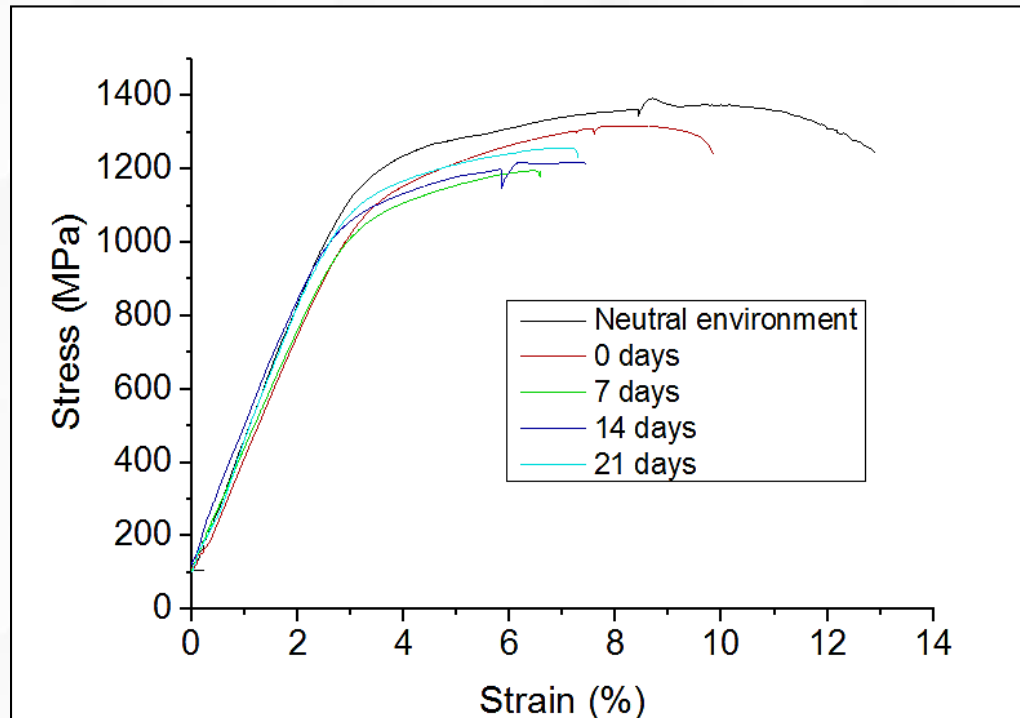
- Tests on SSRT did not indicate SCC-CO<sub>2</sub>, given that the resistance limit is reached (it has ductile characteristics).
- Decreased yield strength and strength limit between 0 and 7 days of pre-corrosion

A clear influence of **pseudo passivation**.

- After 7 days of exposure, the curves practically overlap.

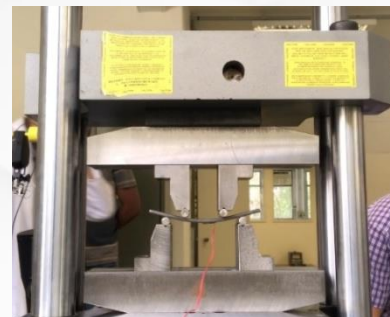
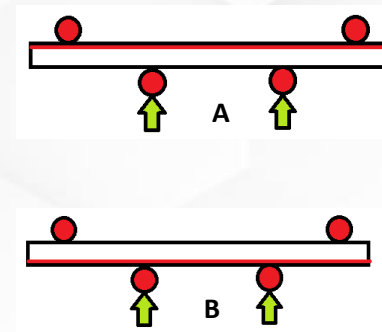
- ▶ 3 specimens (dimensions of the original wire) were plastically deformed in the following sequence: 2 %, -2 %, 2 %, -2 %, and 1.7 %.
- ▶ Then, they were placed on the support and then plastically deformed by 2 % and kept that way (last pass of the cycle).
- ▶ The support with the specimen was placed in an autoclave containing substitute ocean water, with 10,6 barg of CO<sub>2</sub>, a 40 °C with V/A ratio of 1 mL/cm<sup>2</sup> for 6 months.

A (2 %) → B (-2 %) → A (2 %) → B (-2 %) → A (1,7 %)

2 %

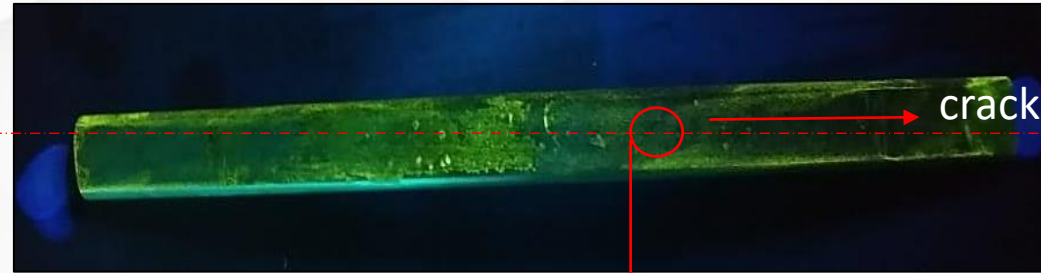
↑ Time  
Only one crack

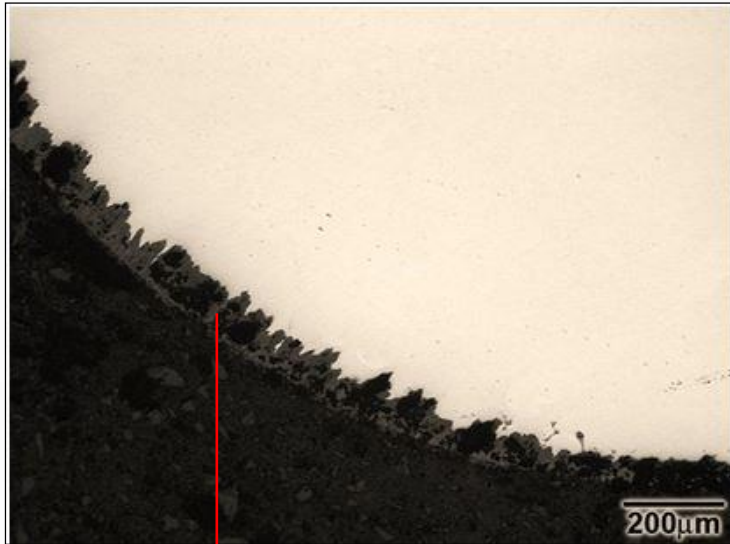
Severe corrosion (transverse)

- Localized corrosion occurred when the carbon steel was immersed in simulated ocean water at 10,6 barg of CO<sub>2</sub>, 40 °C.
- Successive rupture of the FeCO<sub>3</sub> layer by external stress leads SCC-CO<sub>2</sub>

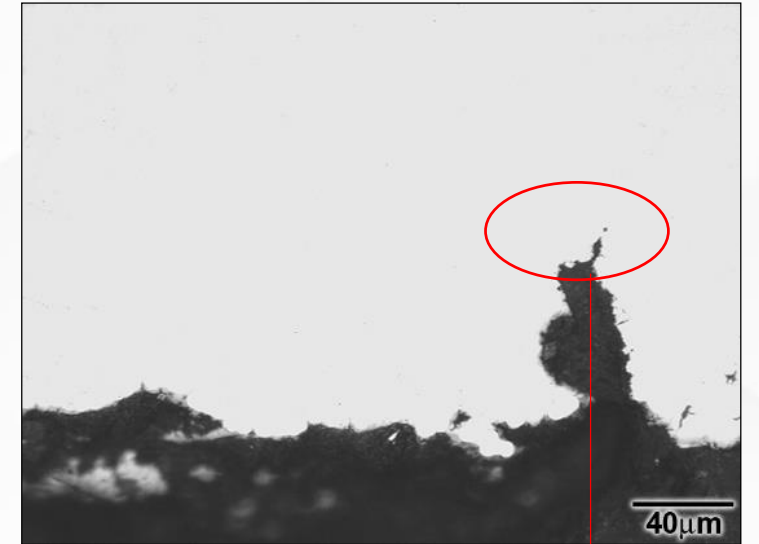
Cracks/fissures

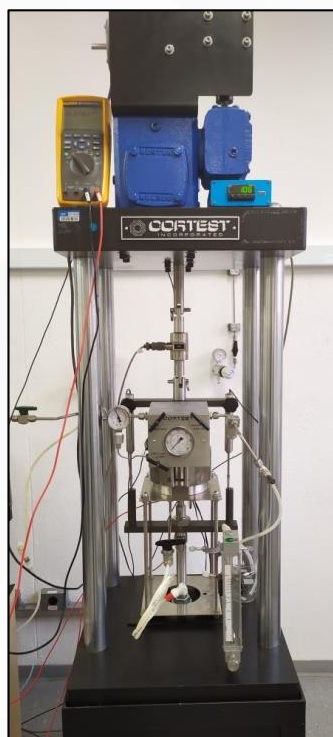
- In order to produce film rupture, cycles of load (90% of yield strength) and unloading (36% of yield strength) were applied in the tensile armour steel specimen
- The period of first cycle of specimen loading must be equal or superior than the pseudopassivation time
- Test duration: 90 days or until rupture.
- Environment: synthetic seawater at 40 °C, 10,6 barg of CO<sub>2</sub>, V/A of 1 mL/cm<sup>2</sup>.
