The internal corrosion in iron or slurry pipeline and the role of chloride ions in depassivation of the steel

*Palestra apresentada no
CONGRESSO
INTERNACIONAL DE
CORROSÃO, INTERCORR,
10., 2025, São Paulo. 31
slides*

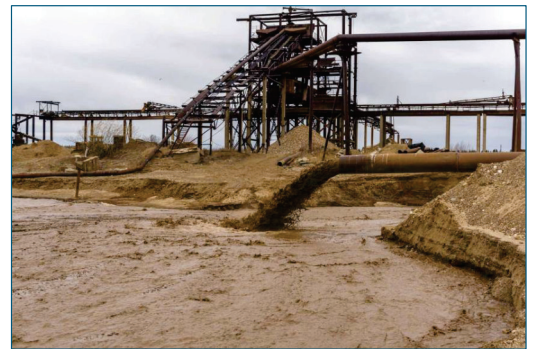
Slurry in Mining

- A slurry is a mixture of solid particles, such as crushed ore or mine tailings, suspended in a liquid, typically water.
- A slurry composition usually consists of a mixture of iron ore and water. The Minas-Rio pipeline transports a mixture that is 70 % iron ore and 30 % water.
- Use alkaline additives (near pH 12) to control corrosion.
 - It forms a thin passive layer on carbon steel.

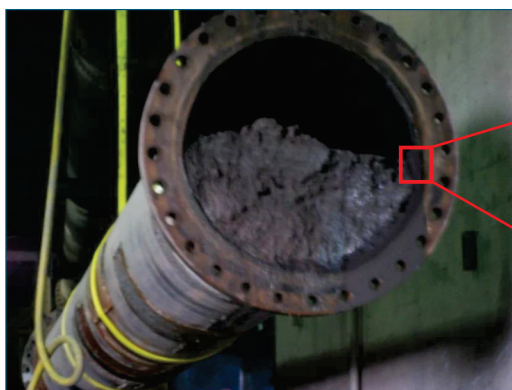
Part 1: External part of the tube;

Part 2: Center of the tube;

Part 3: Internal part of the tube.

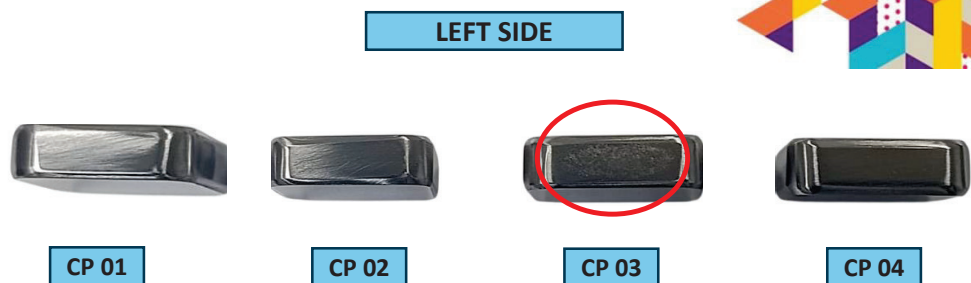
The upper side of the test specimens corresponds to the external region of the tube. Note that corrosion is present only in CP 03.

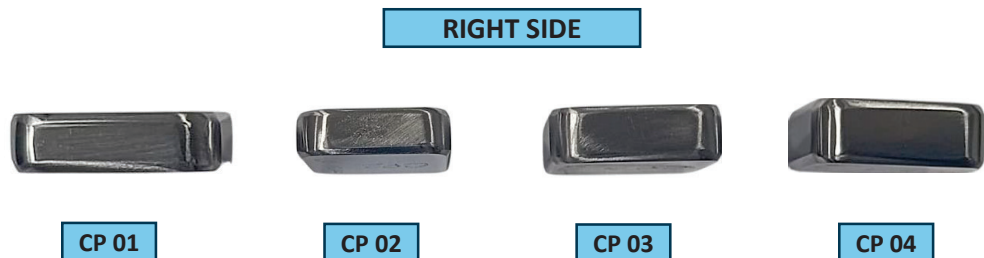
The upper side of the test specimens corresponds to the external region of the tube.
 None of the specimens show visible corrosion.

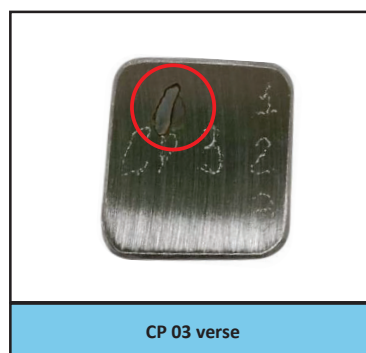
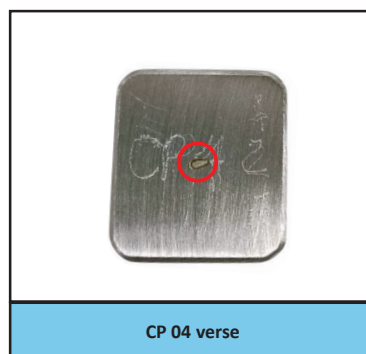
After two days of testing, slight crevice corrosion points appeared on the bottom side of the specimens immersed in pH 11.5. However, those immersed in pH 12.0 did not show any visible signs of crevice corrosion.
