Failure analysis of a fractures orthopedic implant

Failure analysis of a fractured orthopedic implant

Institute for Technological Research of the State of São Paulo (IPT)

Tenth International Conference on Engineering Failure Analysis – ICEFA X

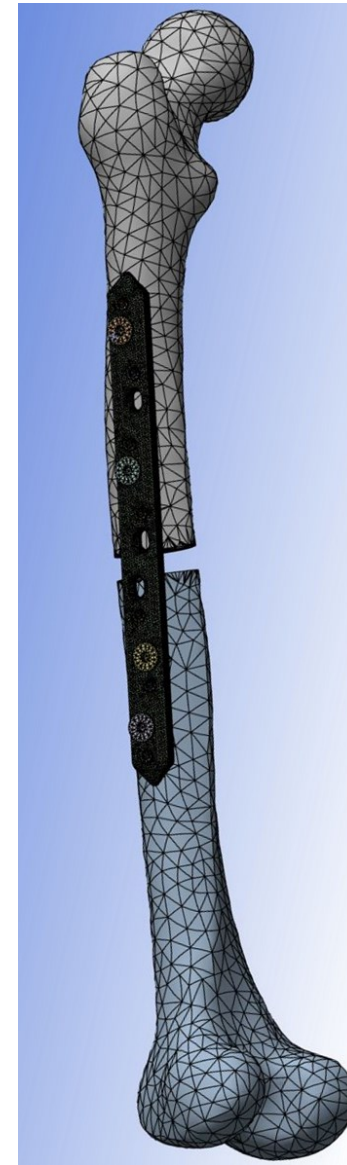
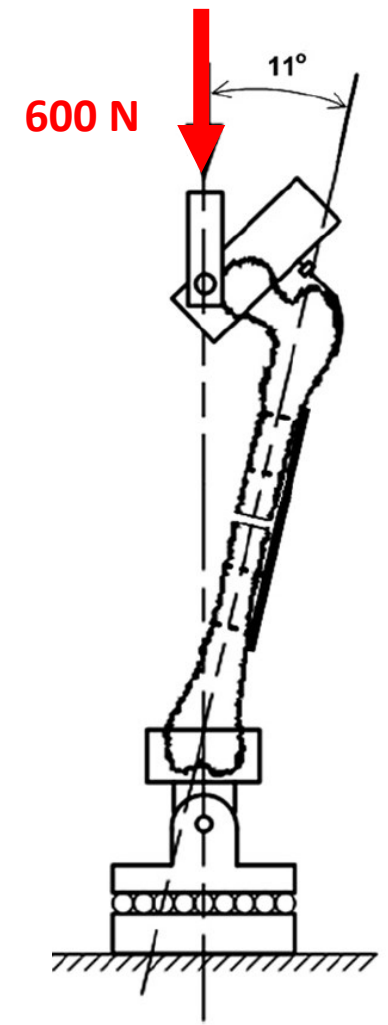
Holes #6, #7 and #11: no screws
Bone fracture region = gap

Loading: **600 N** at 11° angle to simulate weight bearing (leads to bending stresses)

Hole #6: 748 MPa

Hole #7: 408 MPa

Fatigue limit = 394 MPa [2]
 (cold-worked 316L, R = 0)

**Fatigue failure due to excess loading
 (without bone healing) seems possible**
